Fracking: Pros, Cons, Uncertainty, and Protecting the Safety of Frostburg's

Drinking Water

Mountain Ridge

Environmental Science Students

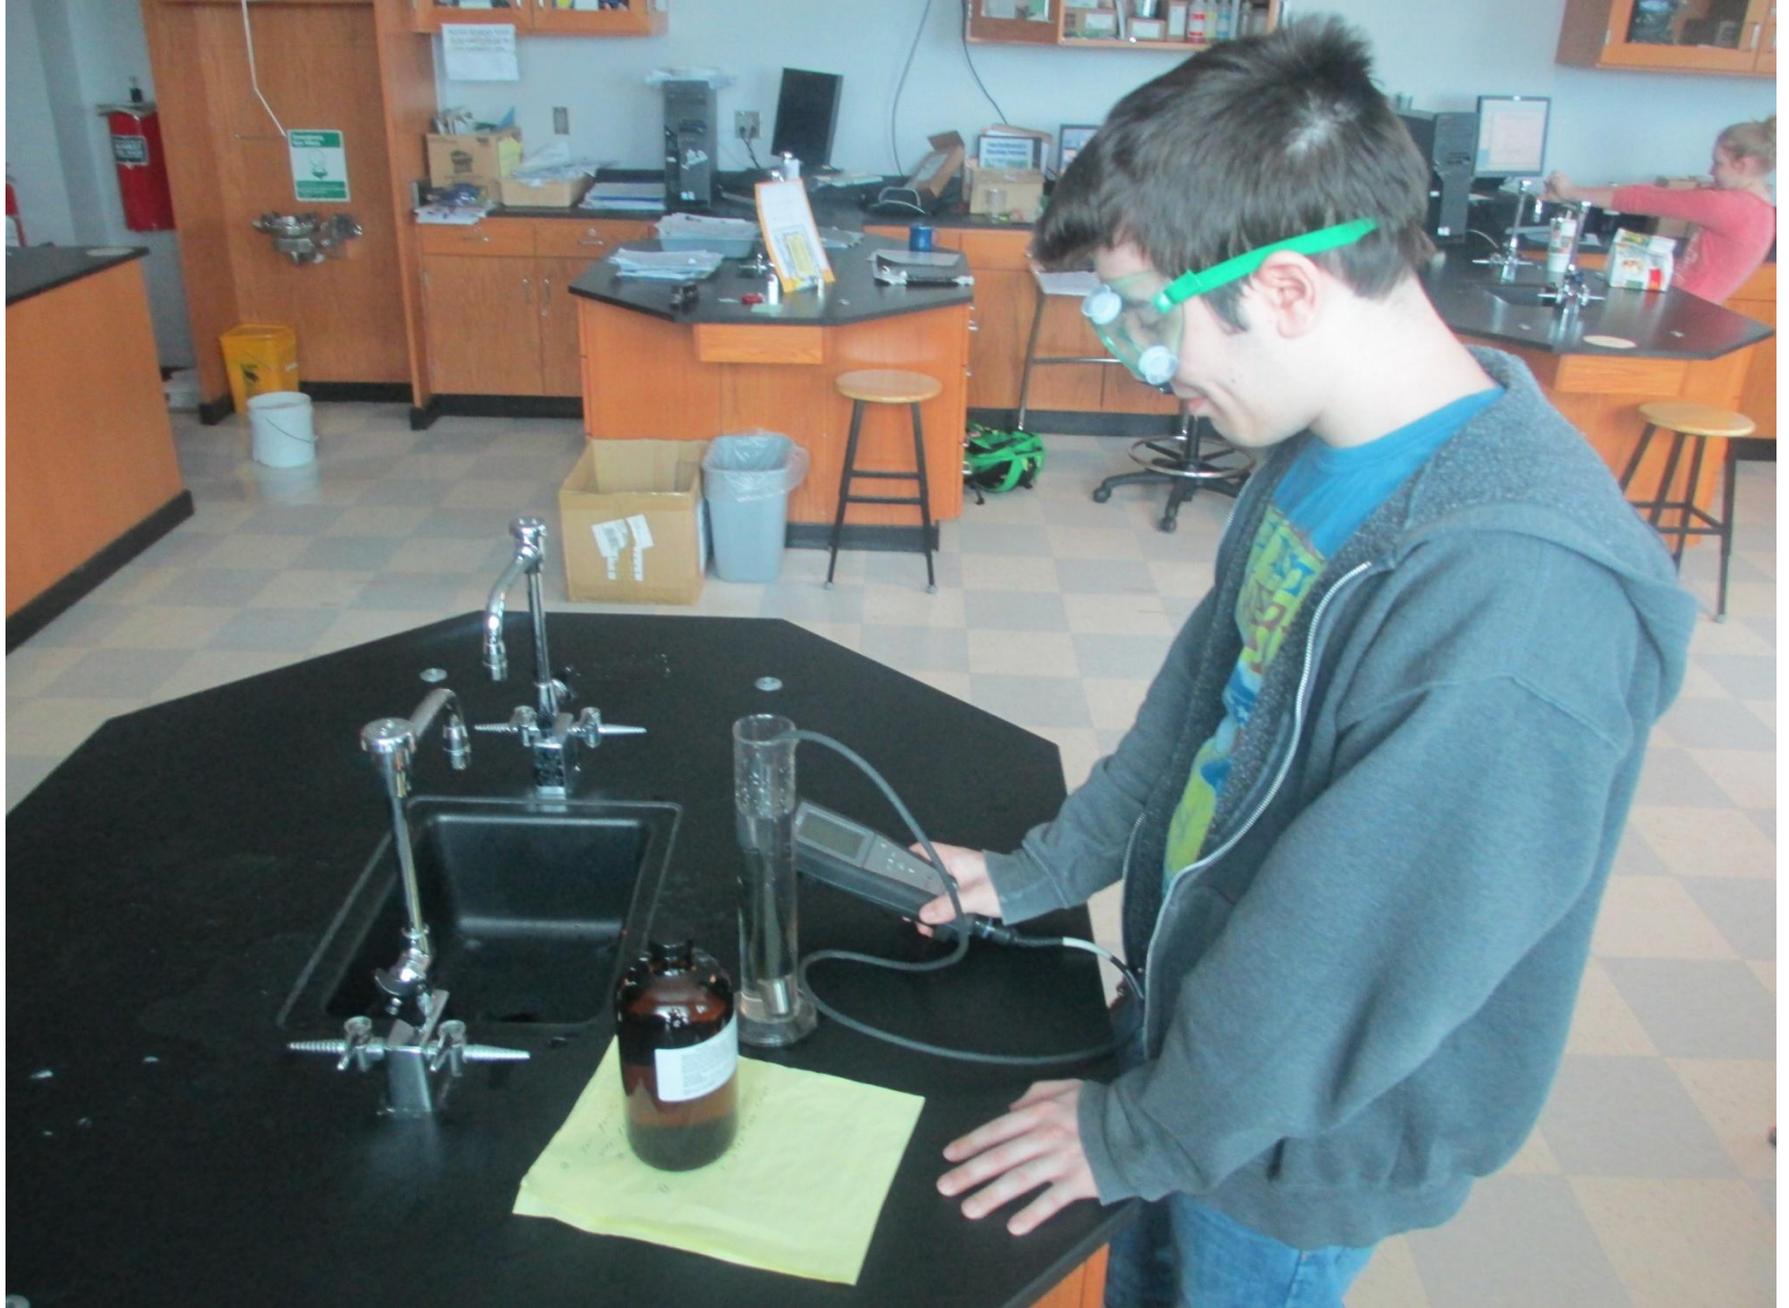
Student calibrating the YSI Pro30

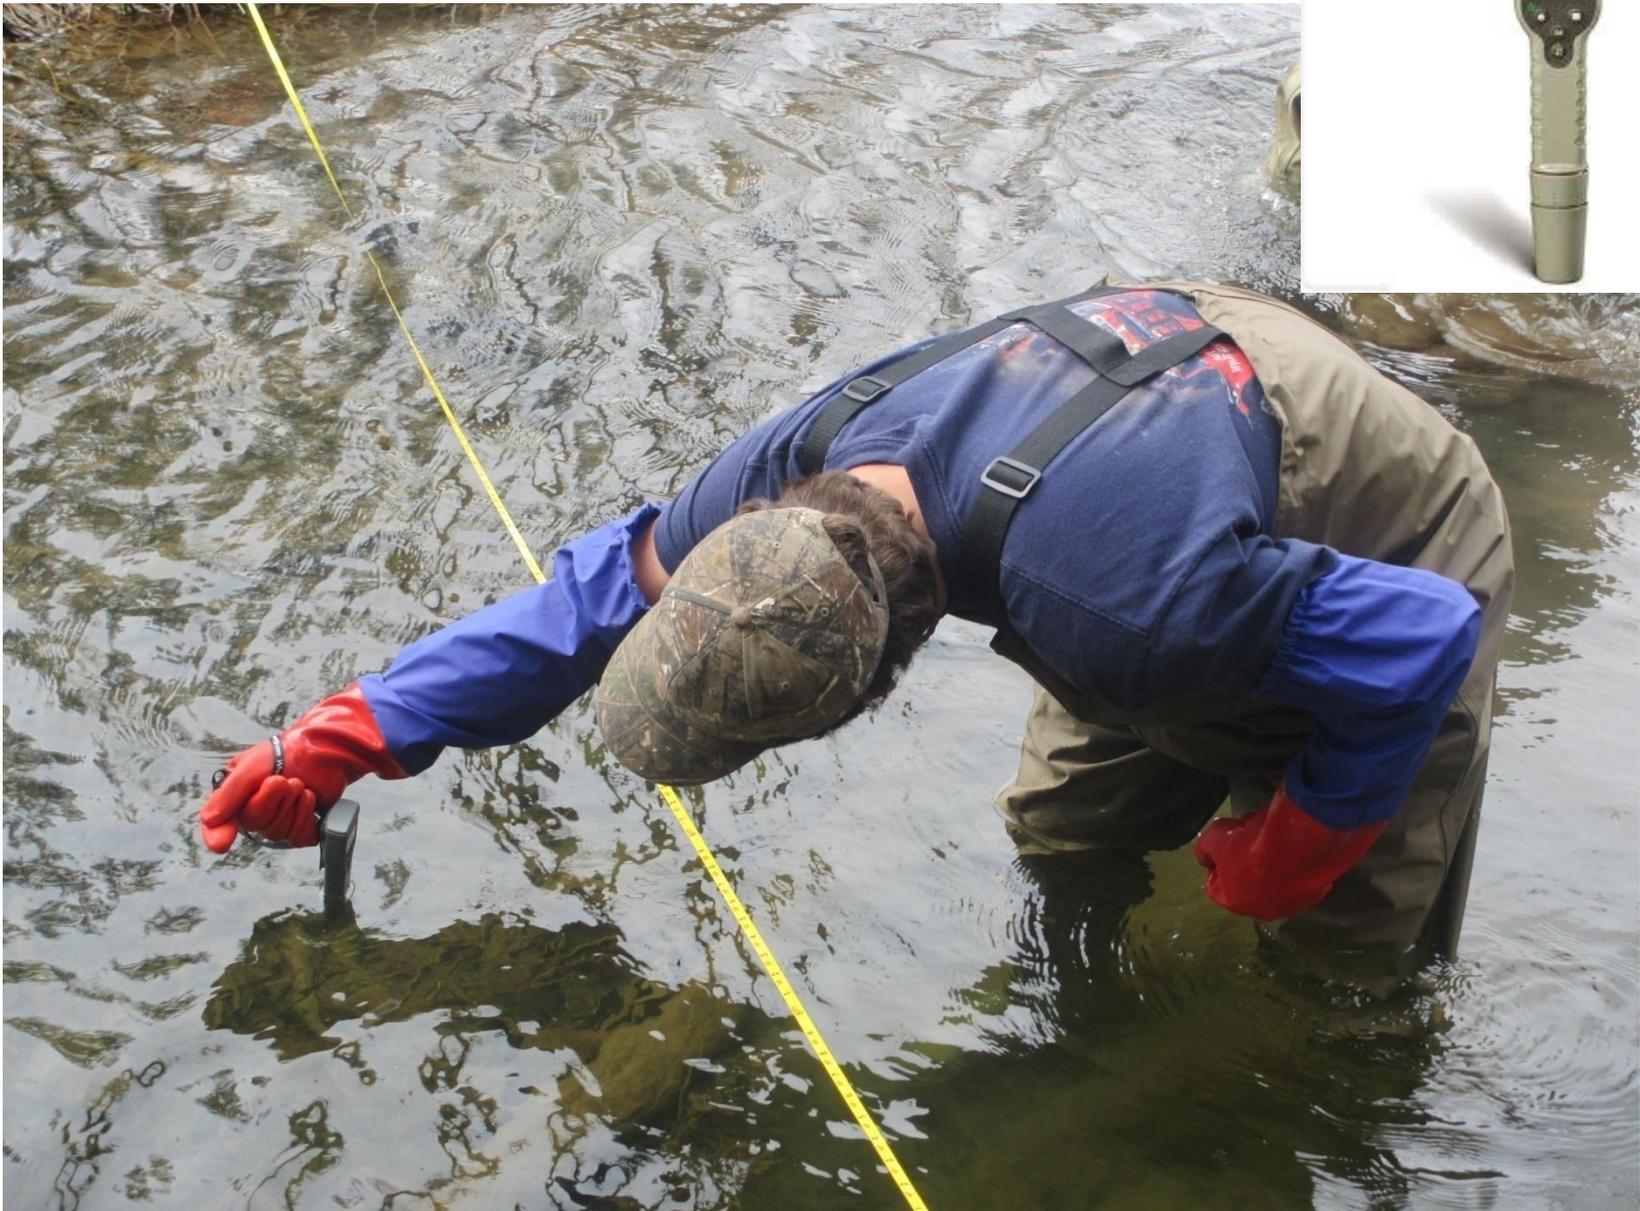
pH was measured using a YSI pH10 Meter

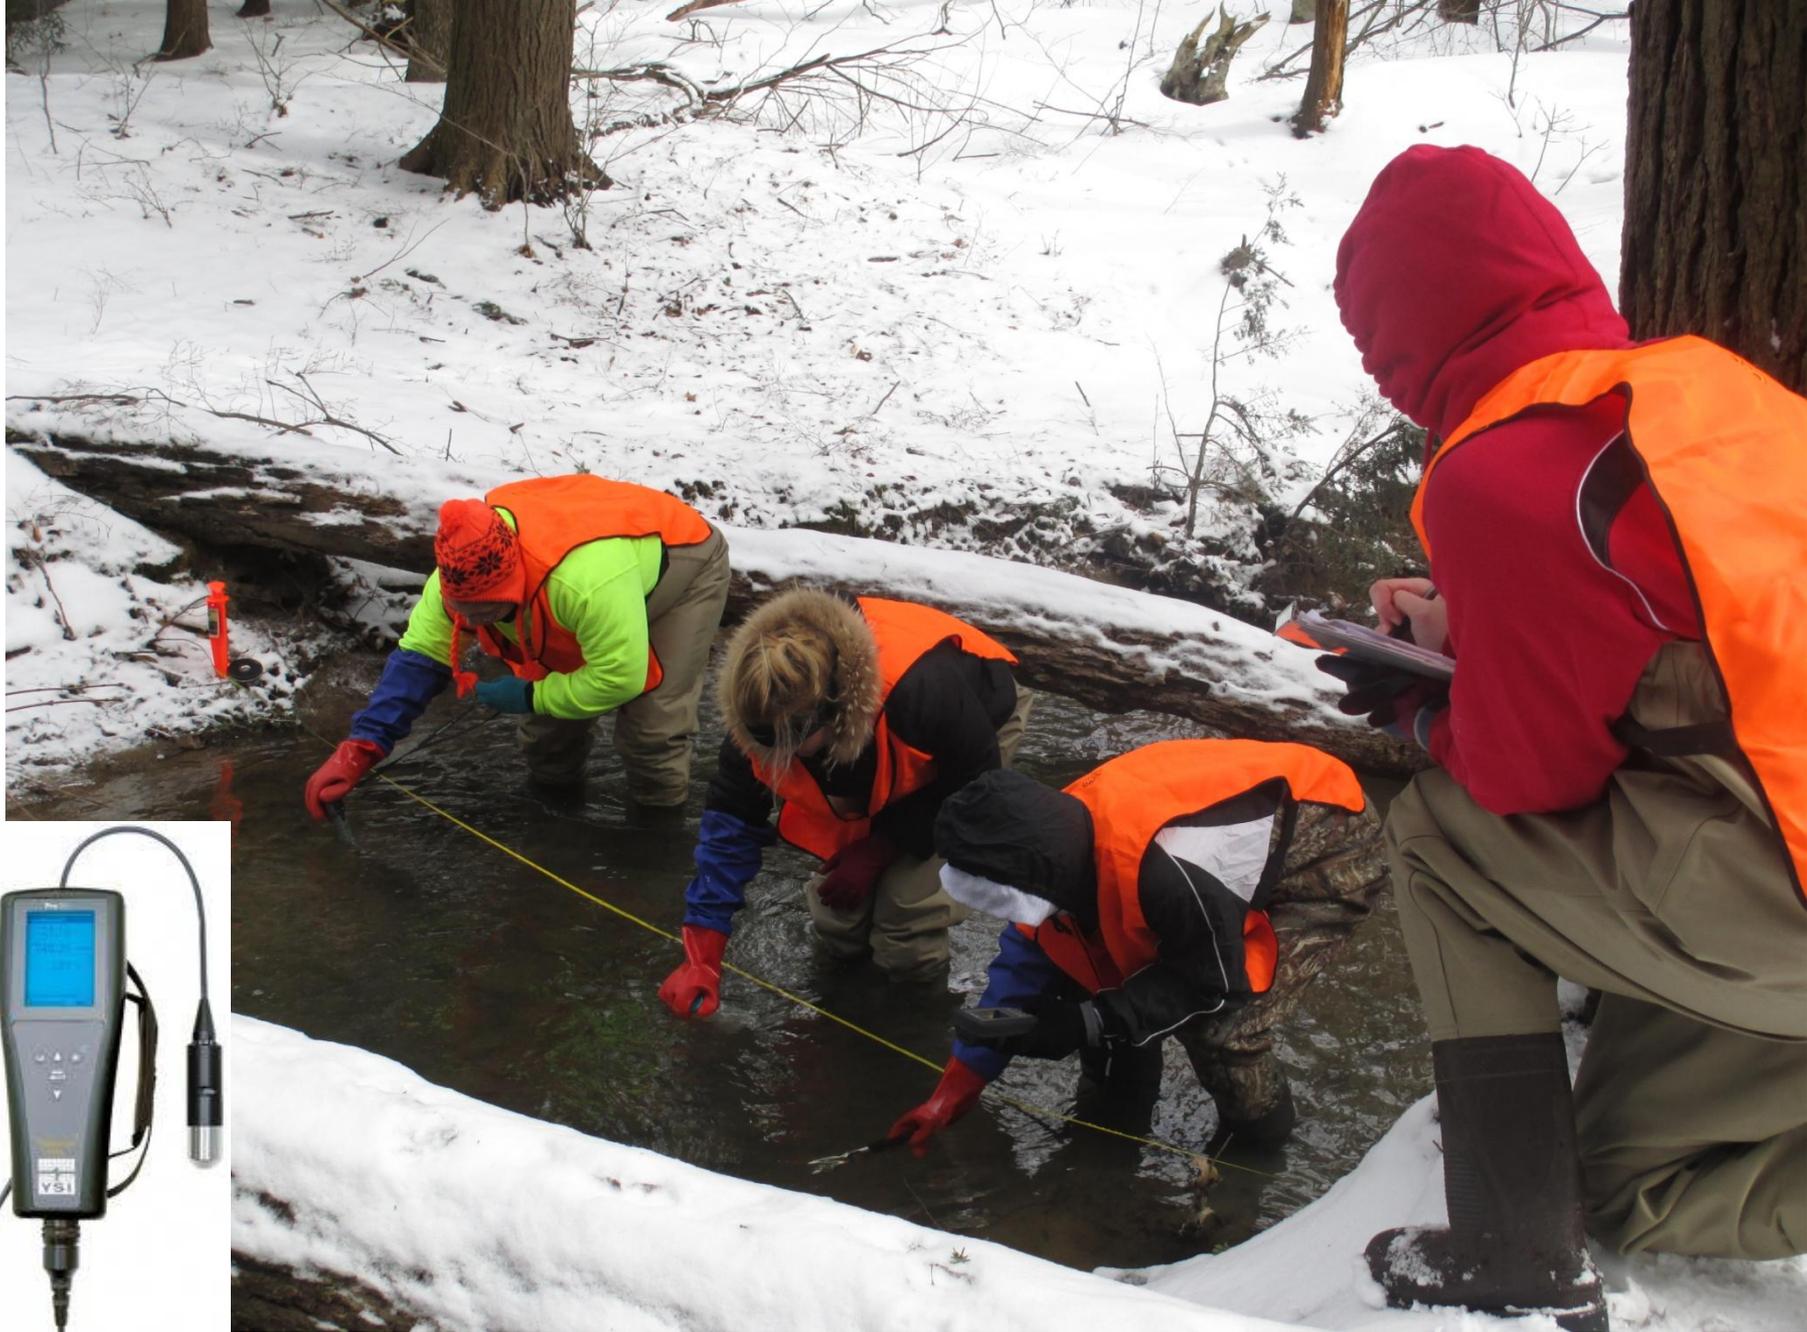
YSI ProODO measures dissolved oxygen

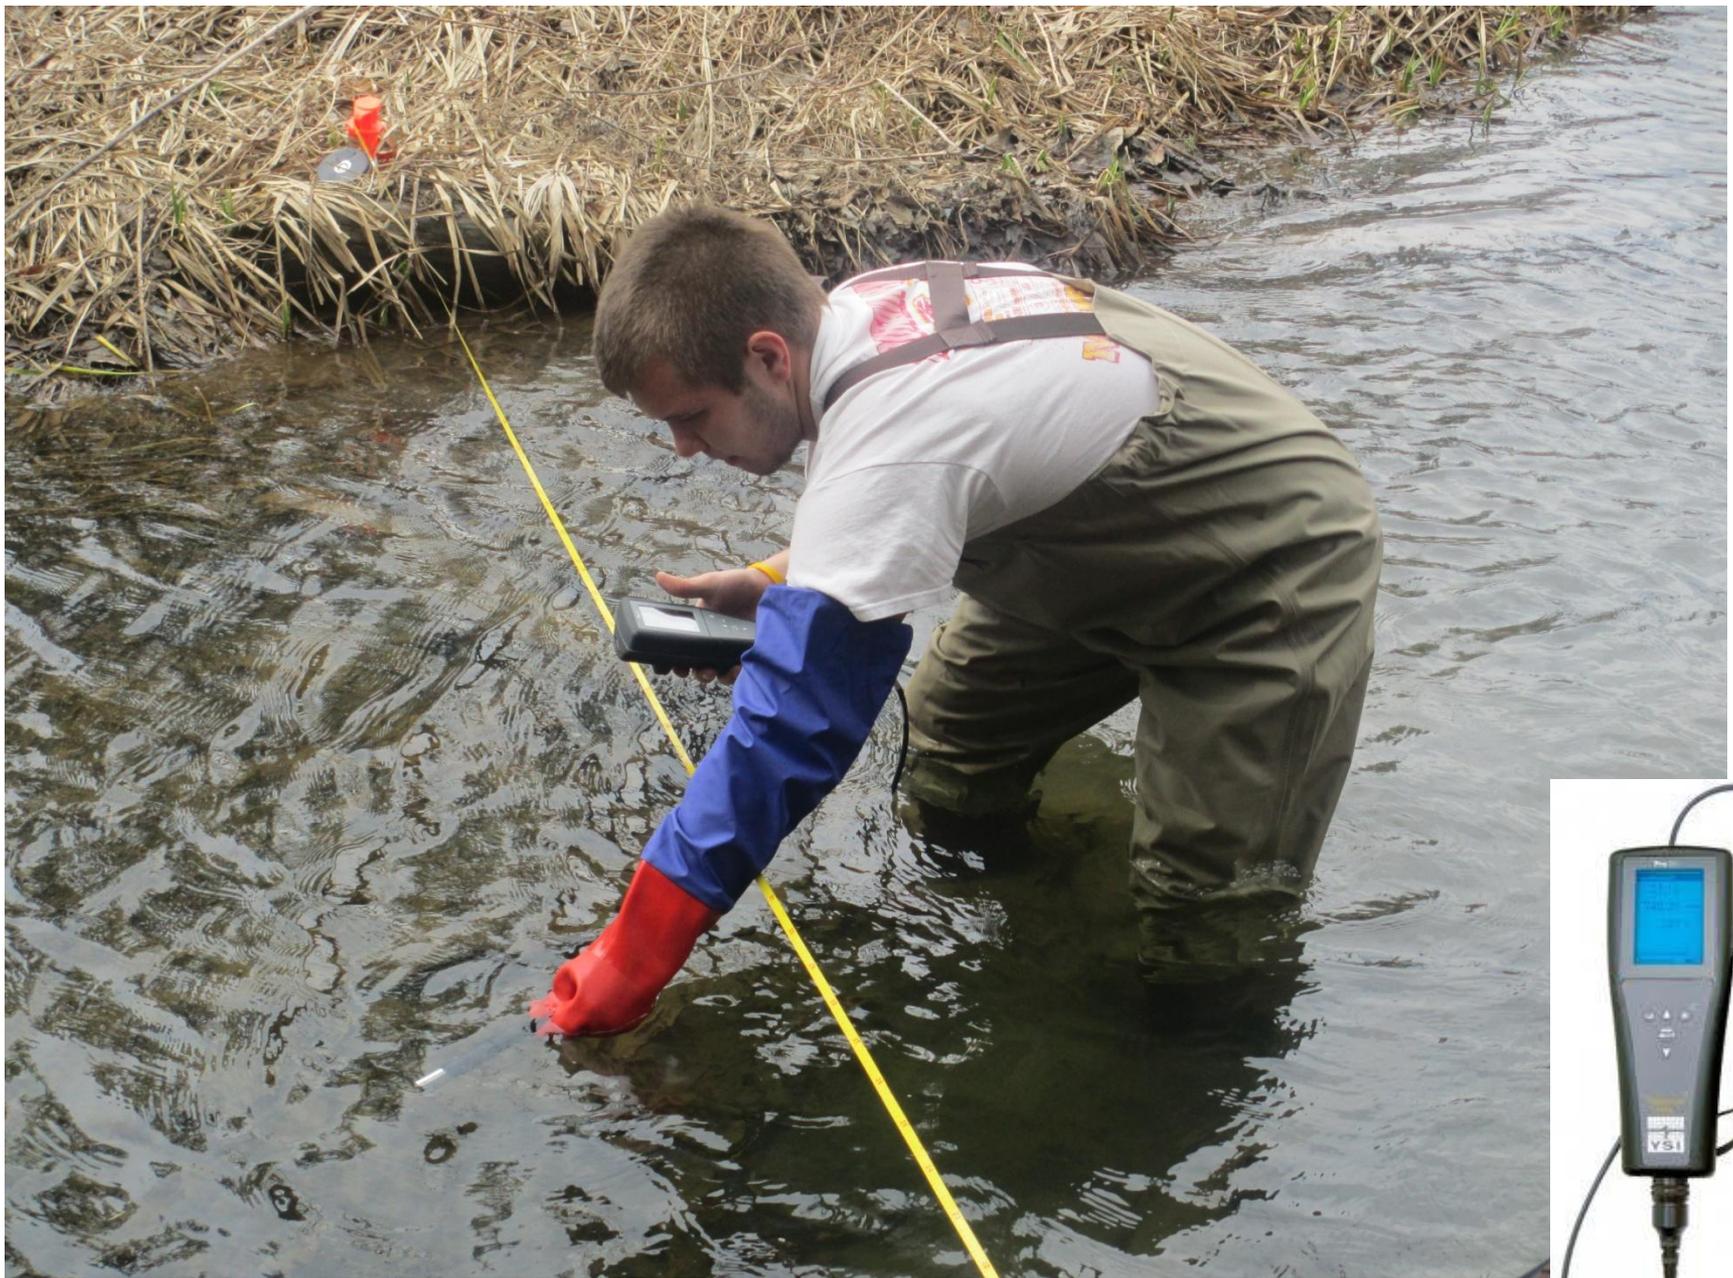
YSI Pro30 measures the specific conductivity

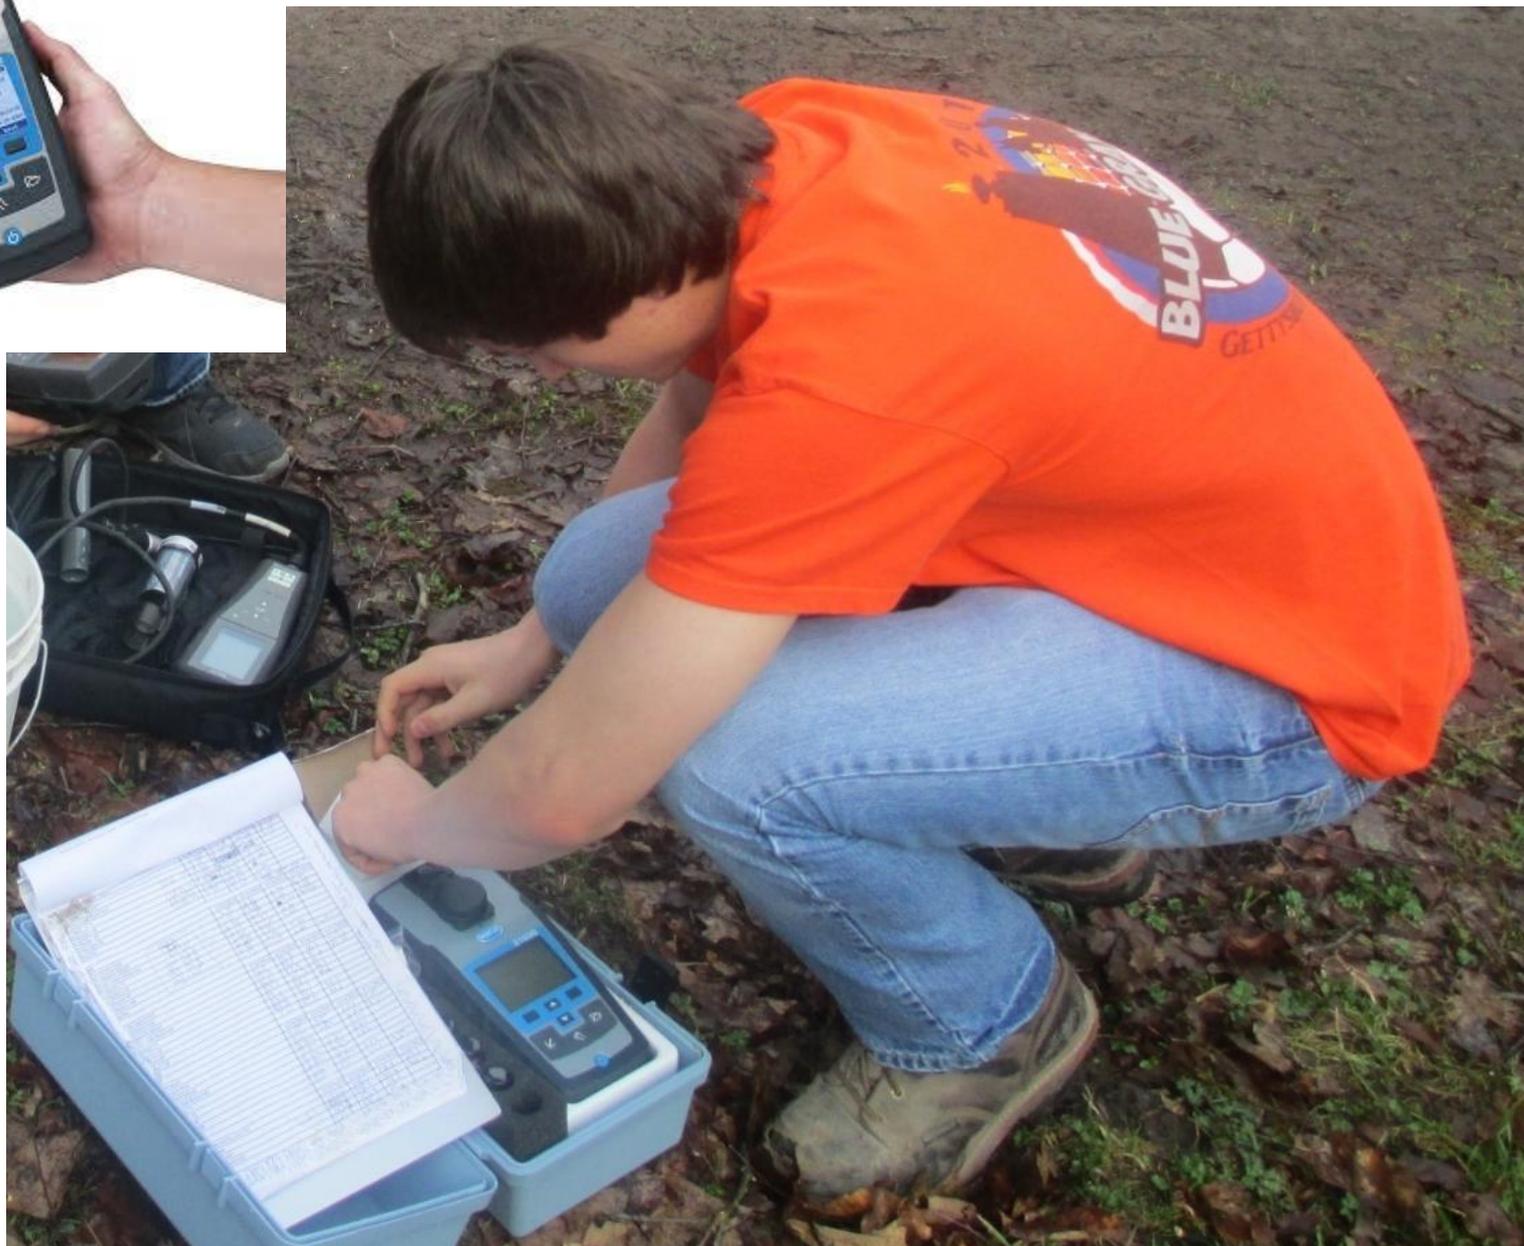
Turbidity being measured using a Hach Turbidimeter

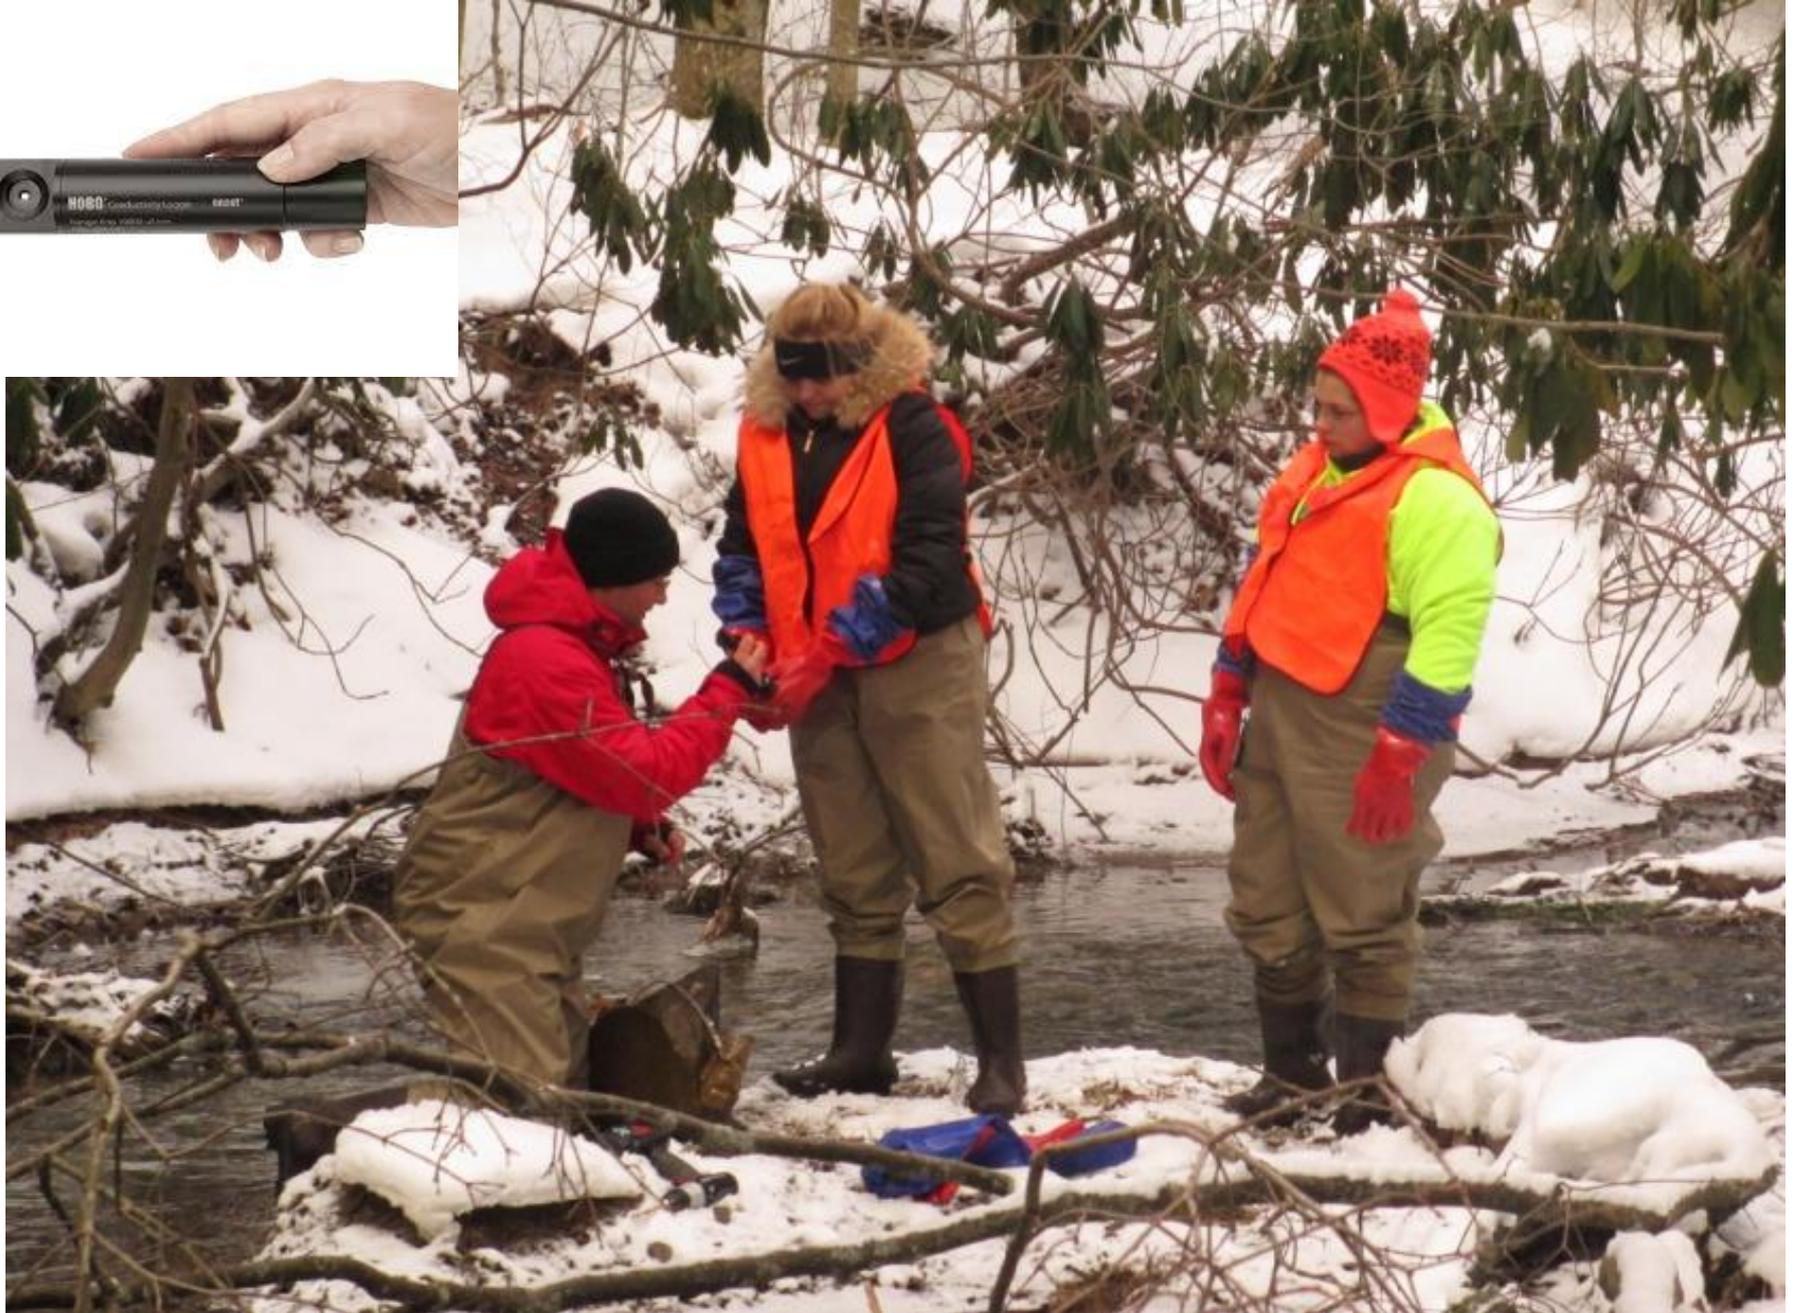
Rock with HOBO monitor is pulled from stream

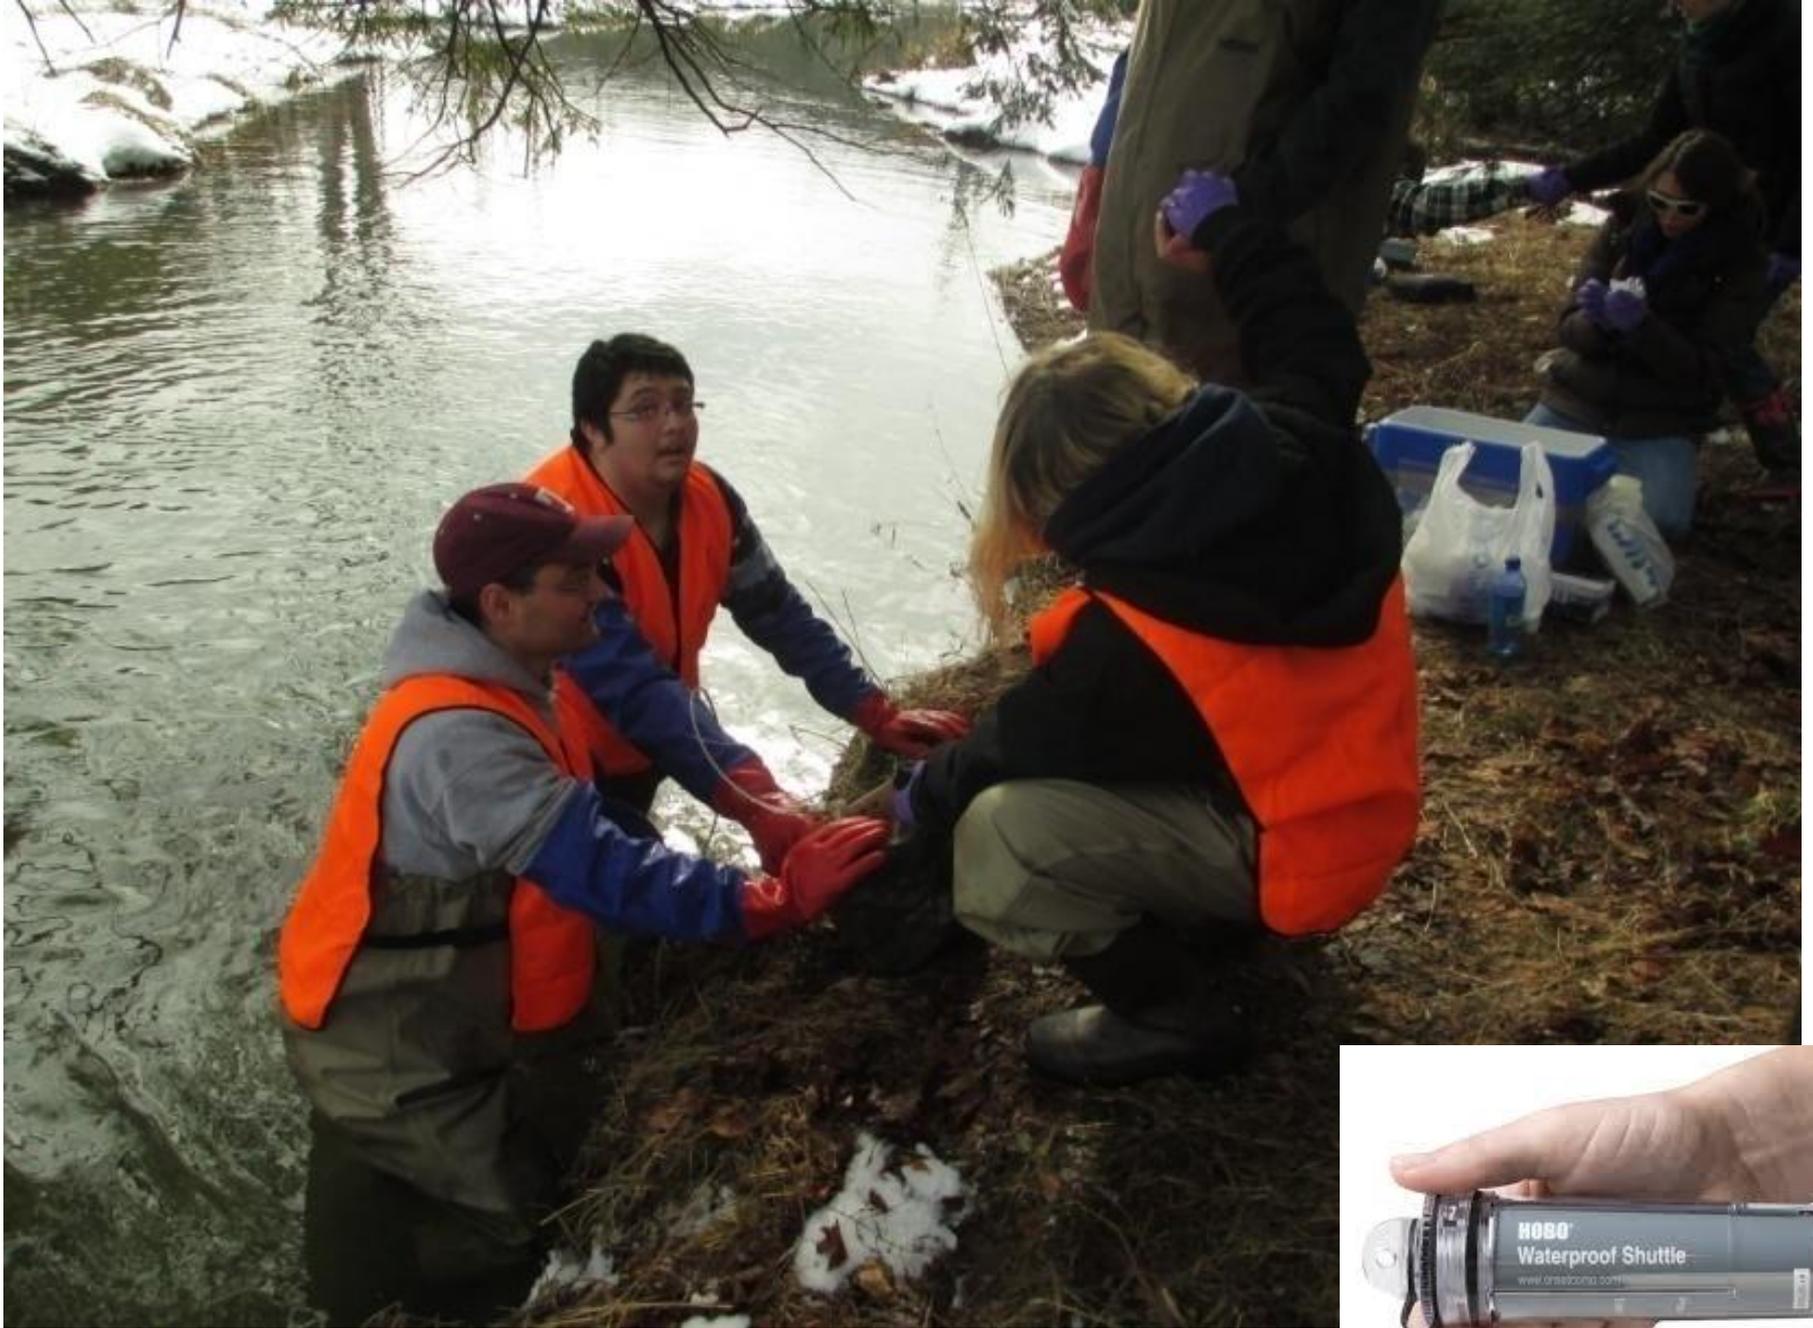
Data is collected off of the HOBOTest monitors

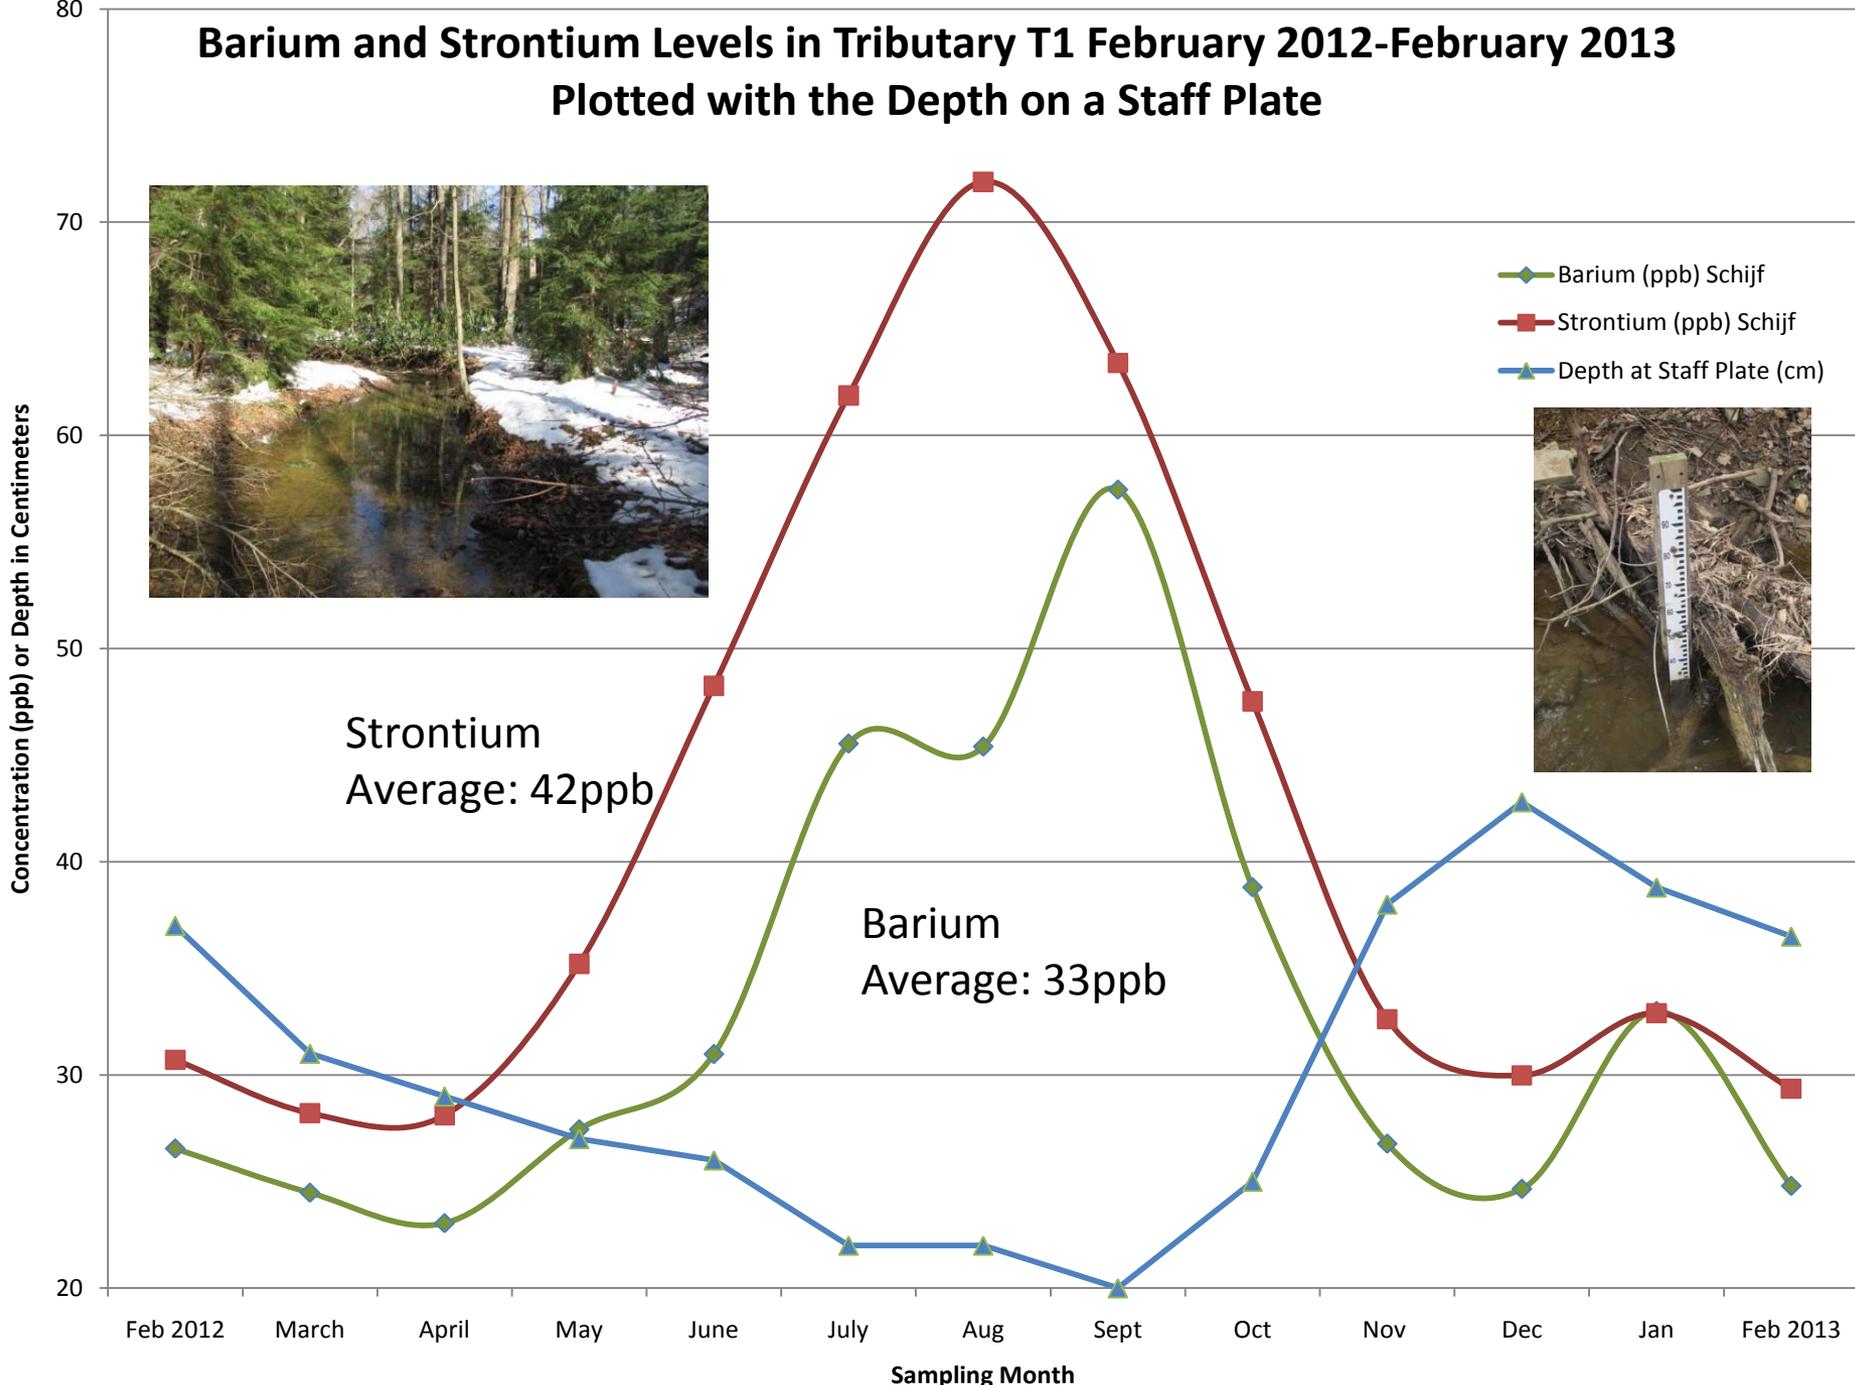
Barium and Strontium Levels in Tributary T1 February 2012-February 2013 Plotted with the Depth on a Staff Plate

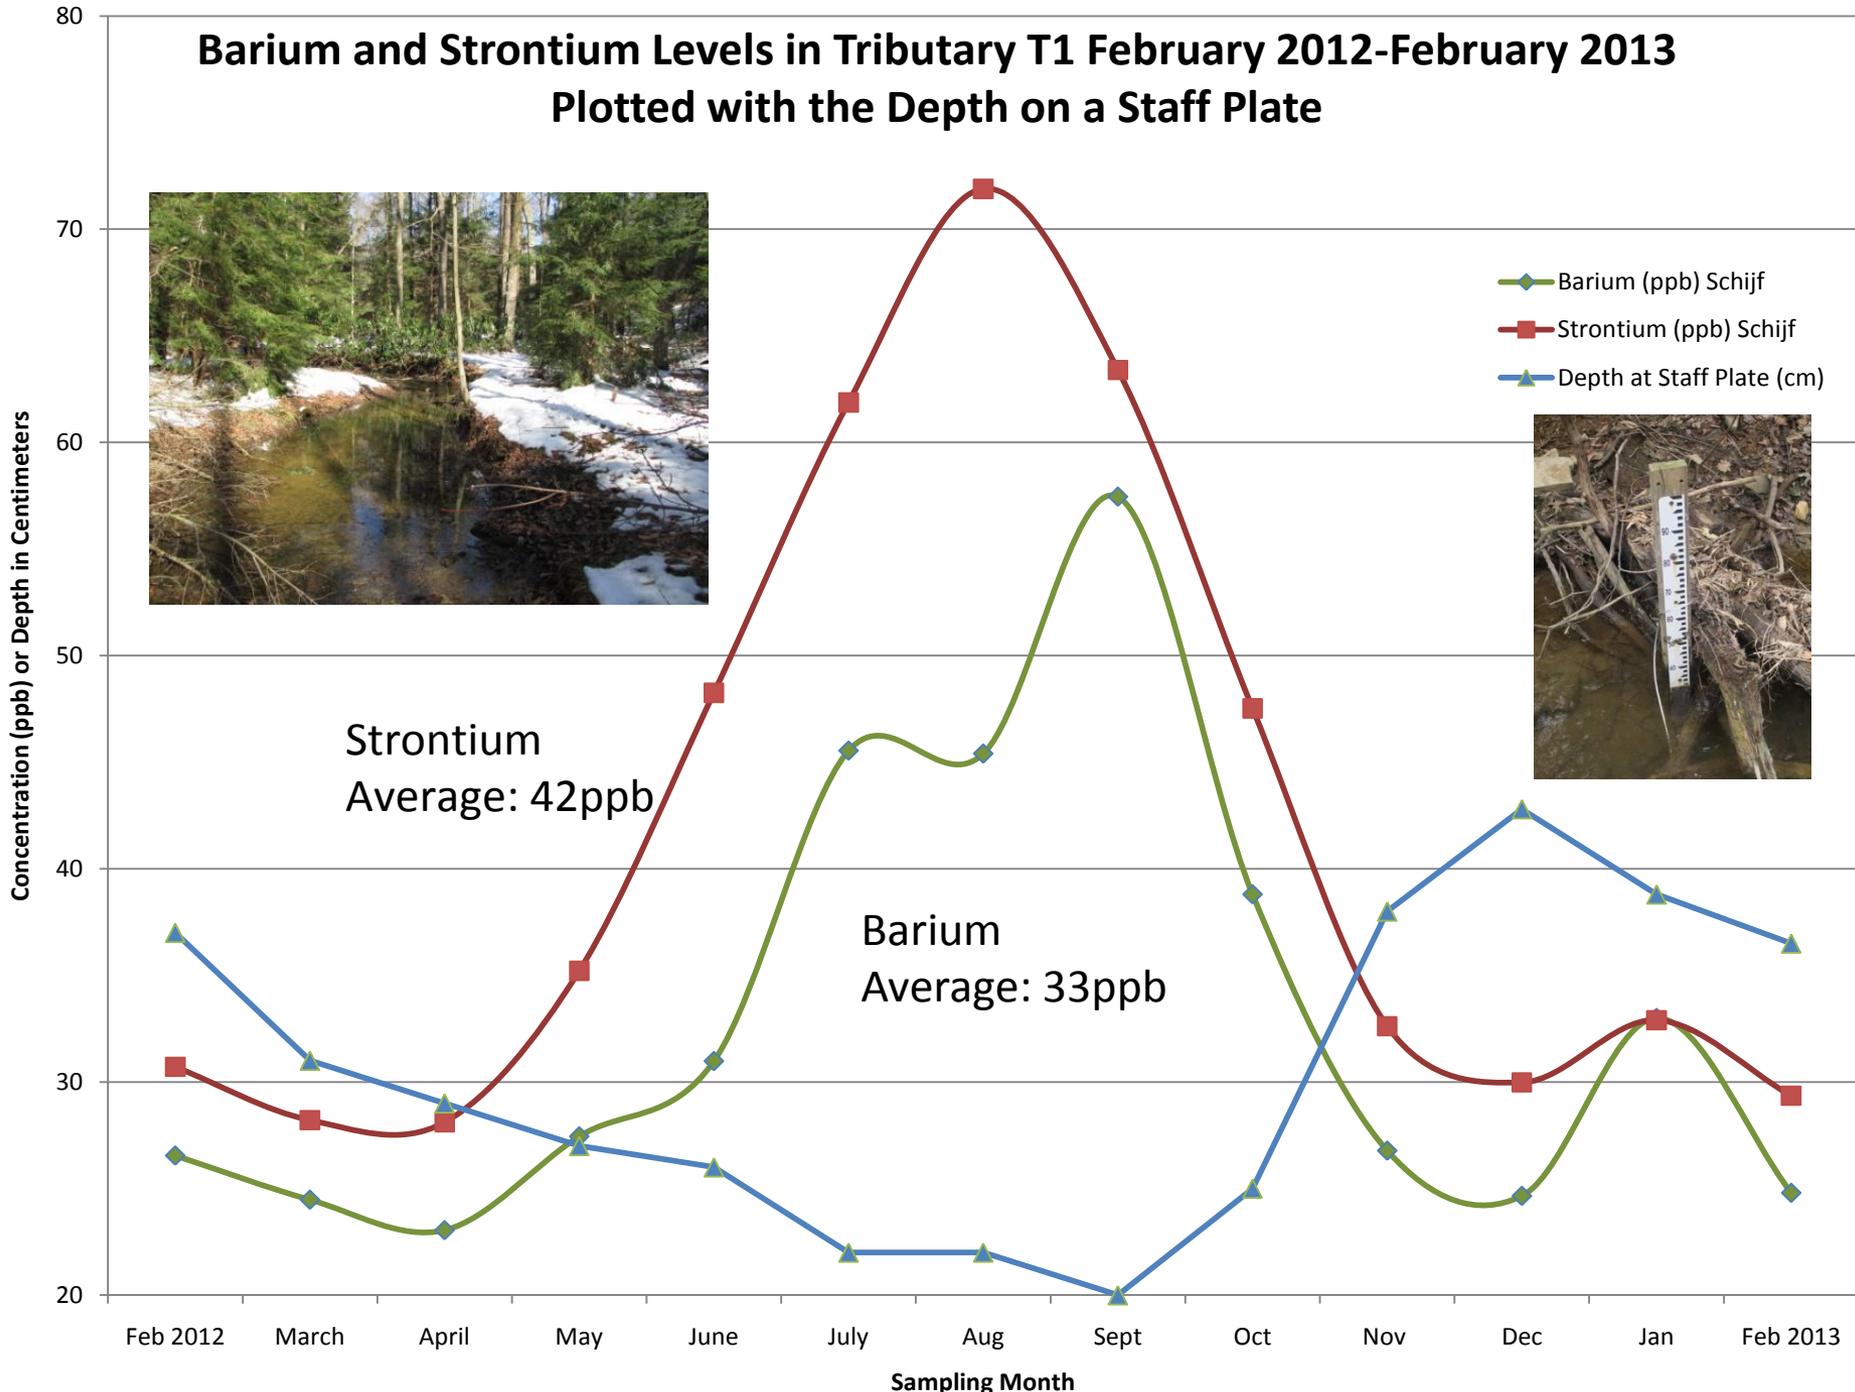
Barium and Strontium Levels in Tributary T1 February 2012-February 2013 Plotted with the Depth on a Staff Plate

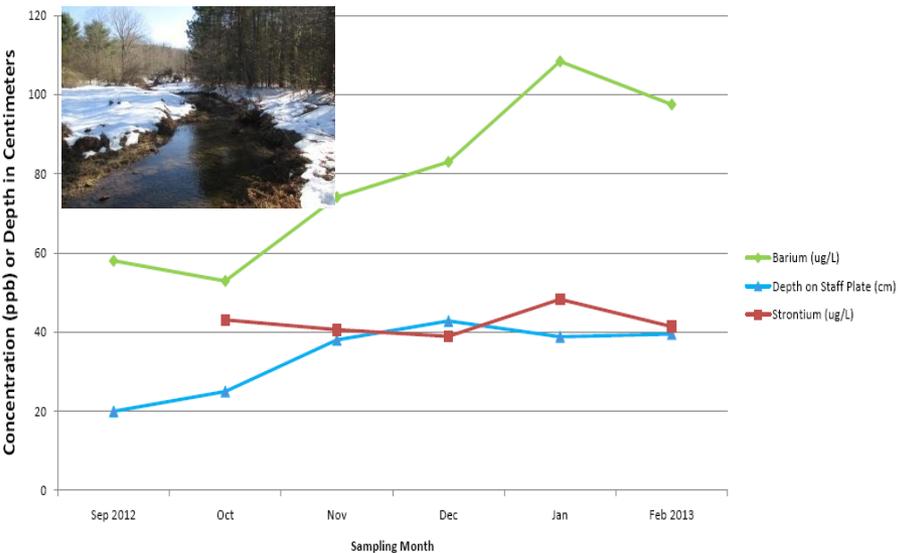
**Barium and Strontium Levels in Tributary B7 September 2012 - February 2013
plotted with Depth on Staff Plate**

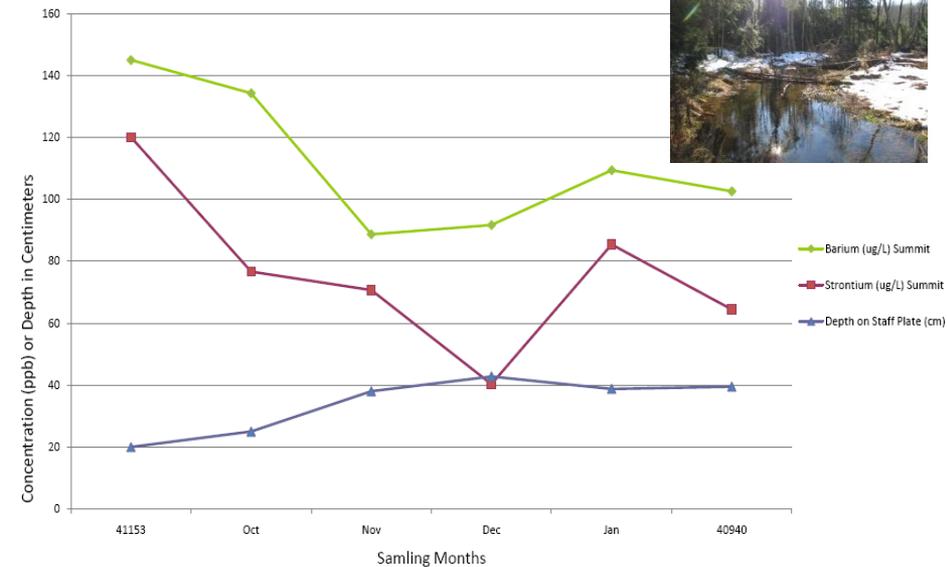
Barium and Strontium in G8 from September 2012-February 2013 plotted with depth at staff plate

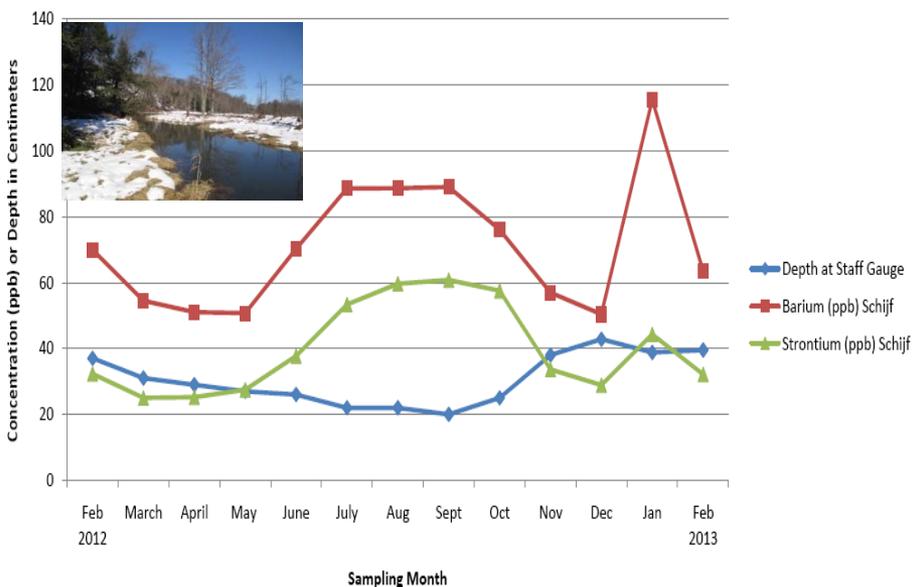
Barium and Strontium at Tributary C6 from February 2012-February 2013 Plotted with Depth at the Staff Plate

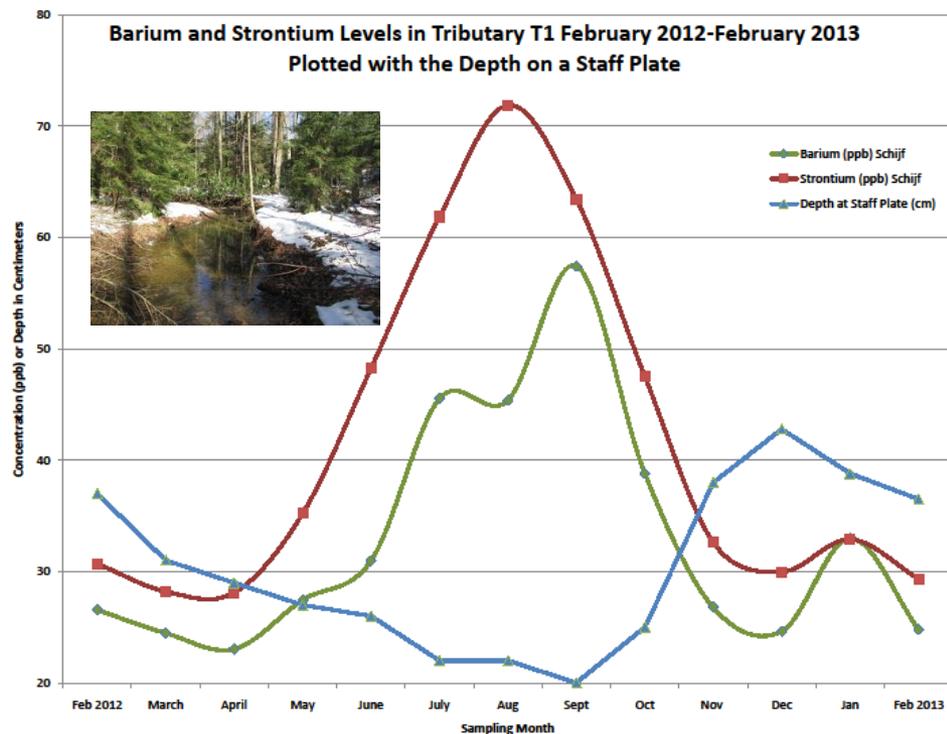
**Barium and Strontium Levels in Tributary T1 February 2012-February 2013
Plotted with the Depth on a Staff Plate**
