Fracking: Pros, Cons, Uncertainty, and Protecting the Safety of Frostburg's

Drinking Water

Mountain Ridge

Environmental Science Students

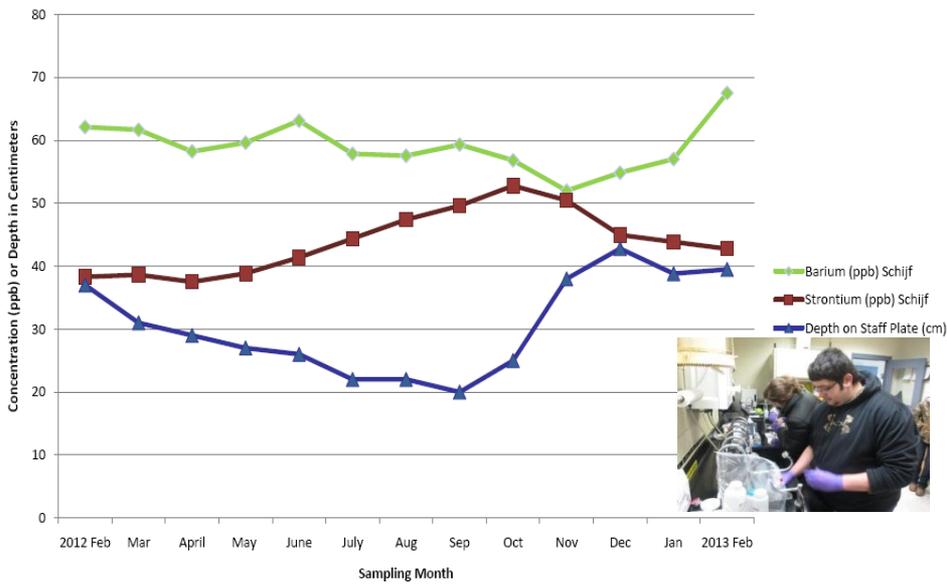
Barium and Strontium Levels in Treatment Mixed February 2012-February 2013 Plotted with the Depth on a Staff Plate

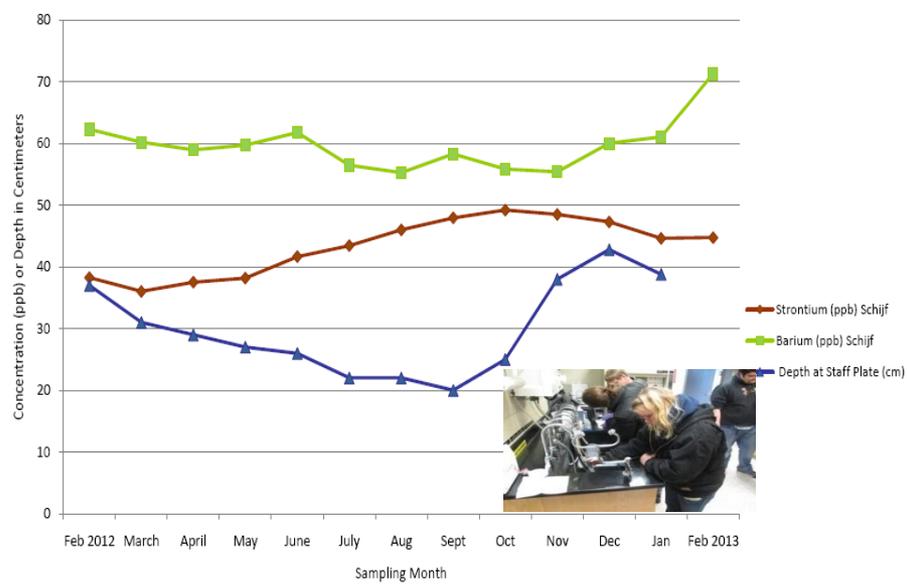
Barium and Strontium Levels in Treatment Raw February 2012-February 2013 Plotted with Depth on Staff Plate

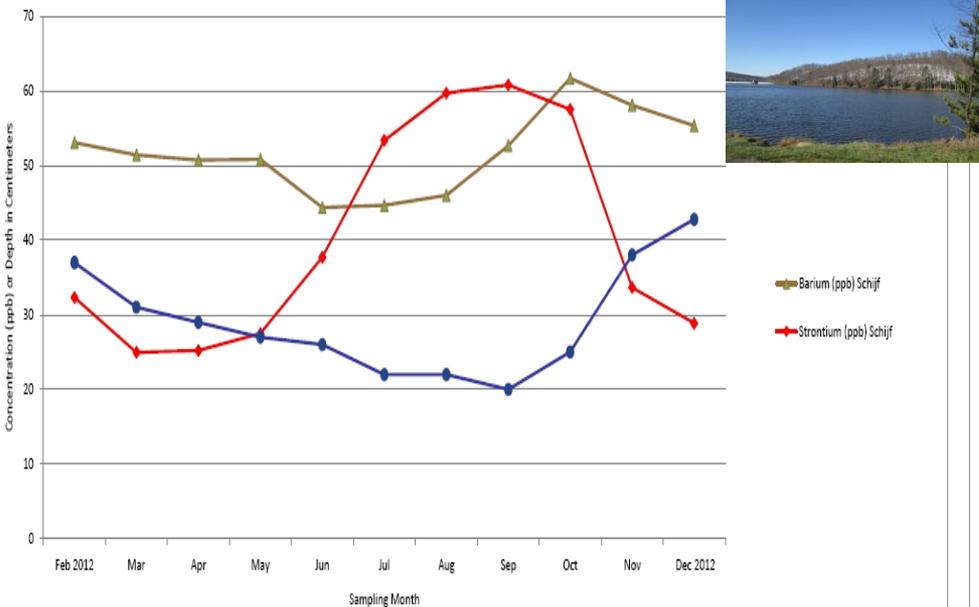
Barium and Strontium at the Frostburg Reservoir from February 2012 to December 2012 plotted with Staff Plate Depth

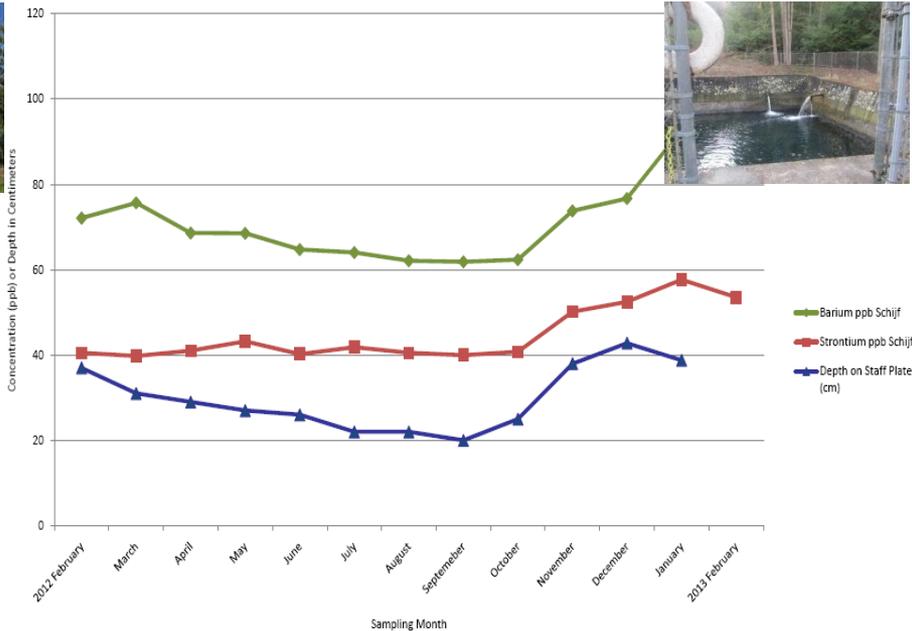
Barium and Strontium Levels in Aquifer February 2012-February 2013 Plotted with Depth on a Staff Plate

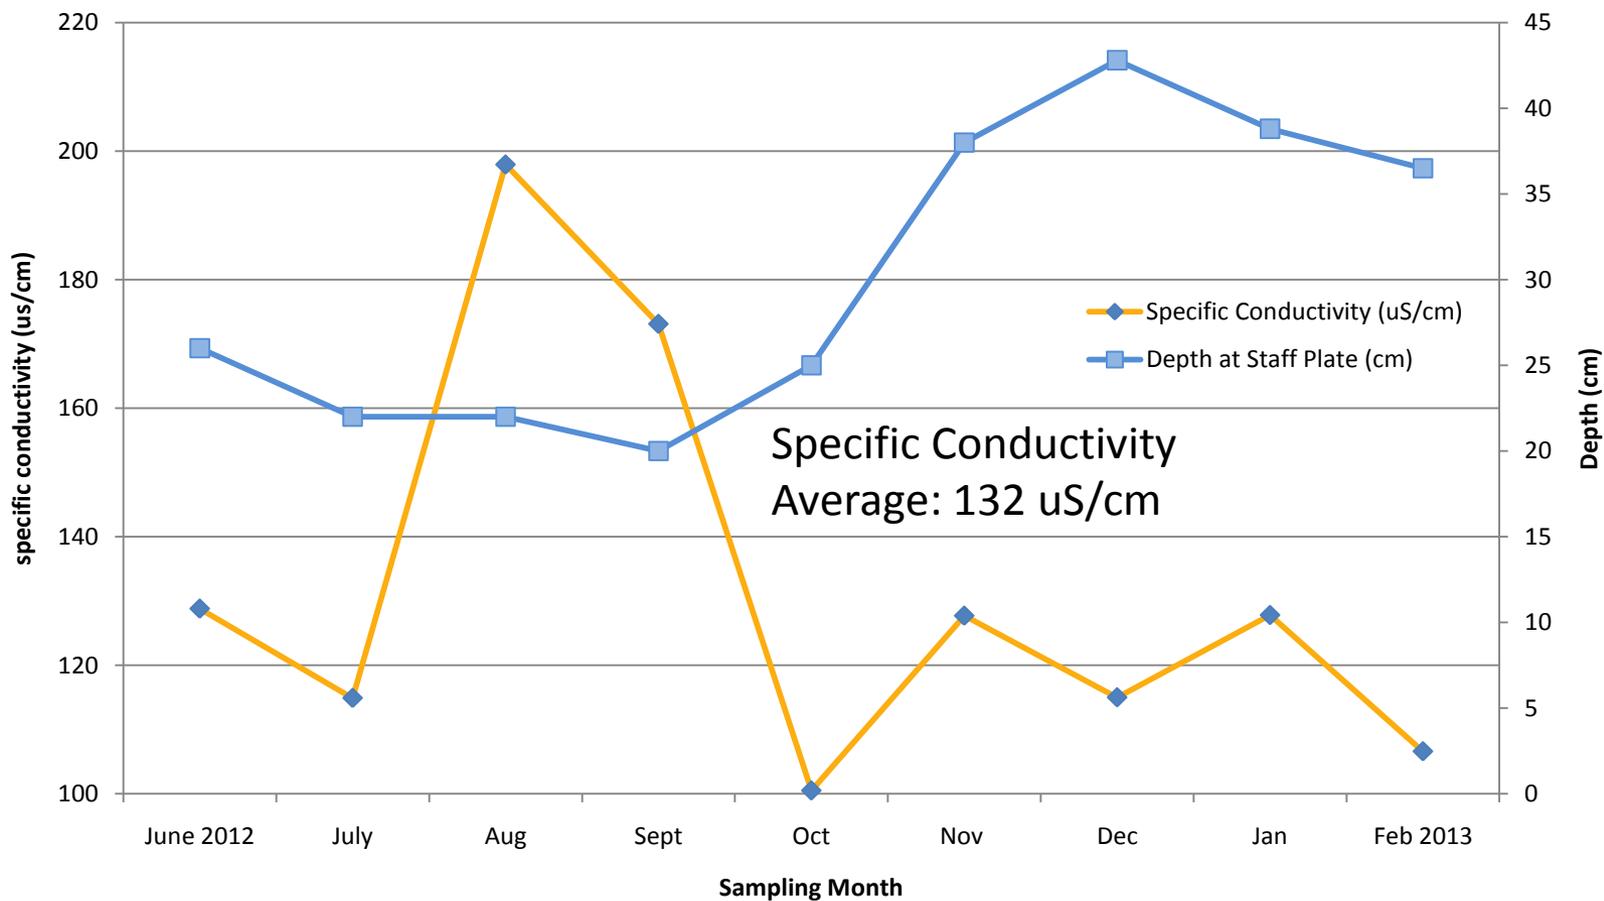
Specific Conductivity in Tributary T1 from June 2012-February 2013 Plotted with Depth on a Staff Plate

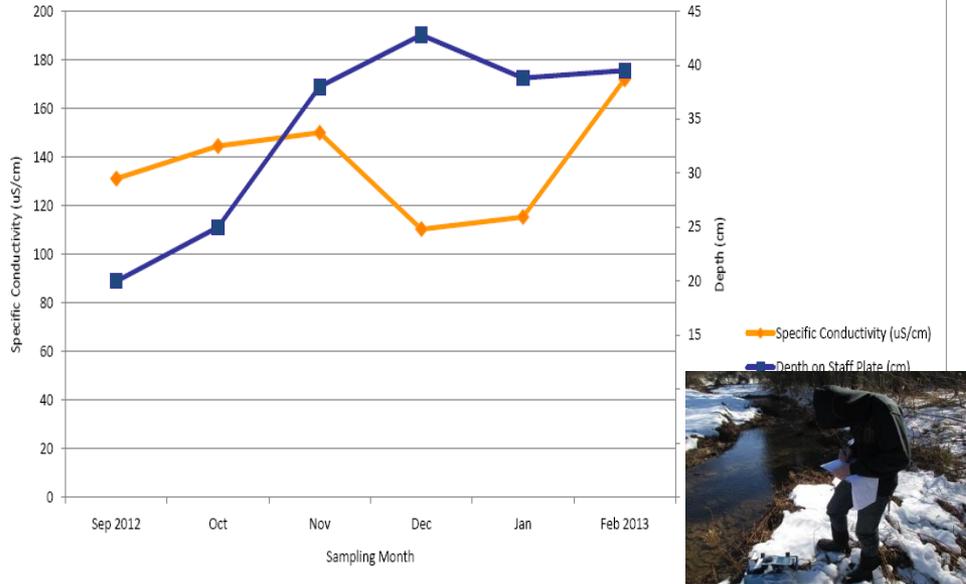
Specific Conductivity at B7 from September 2012-February 2013 Plotted with Depth at Staff Gauge

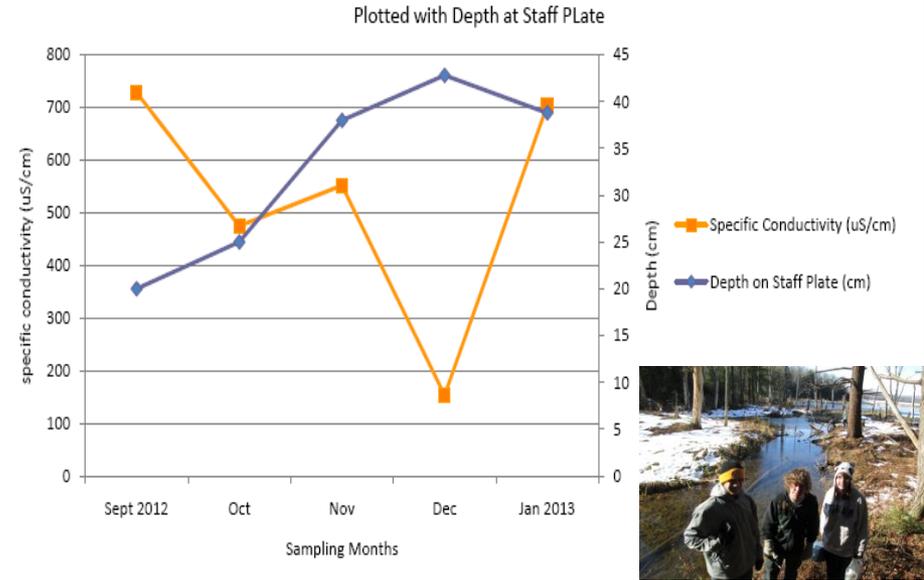
Specific Conductivity in G8 from September 2012- January 2013

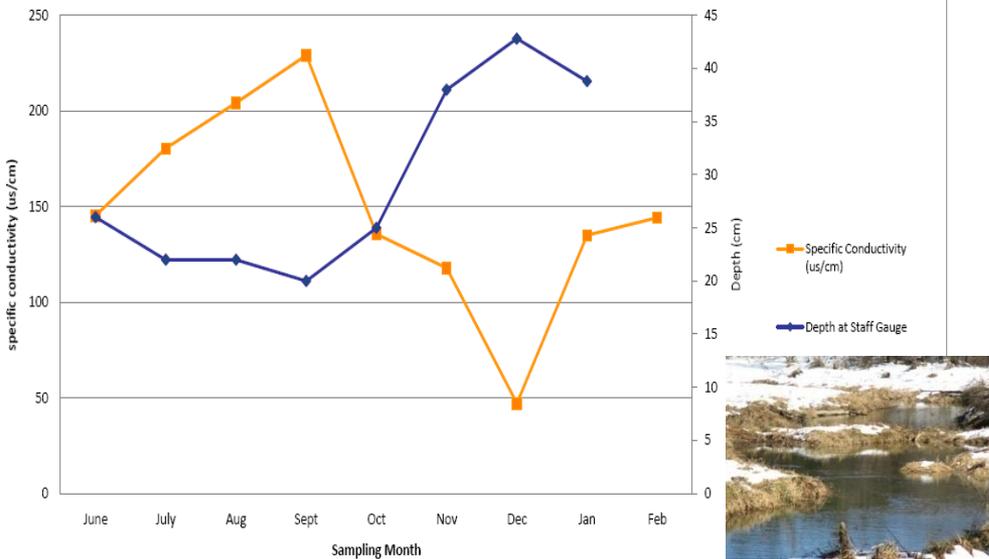
Specific Conductivity in Tributary C6 from June 2012 - February 2013 Placed with Depth at Staff Gauge

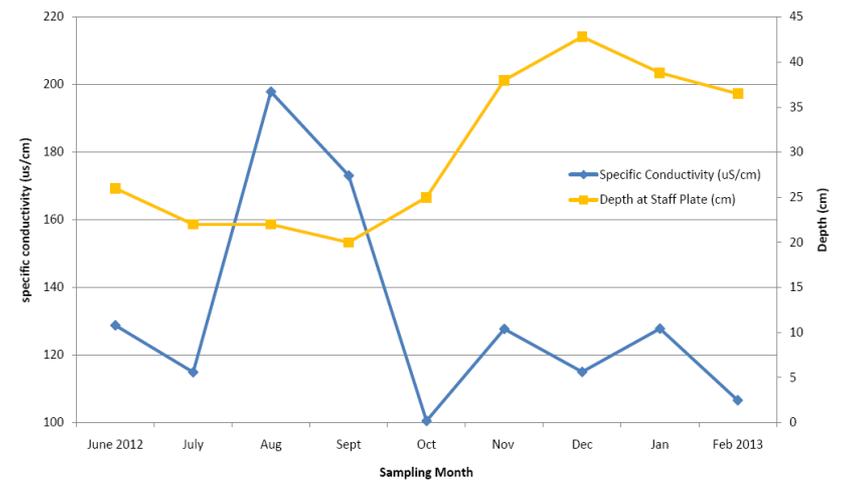
Specific Conductivity in Tributary T1 from June 2012-February 2013 Plotted with Depth on a Staff Plate

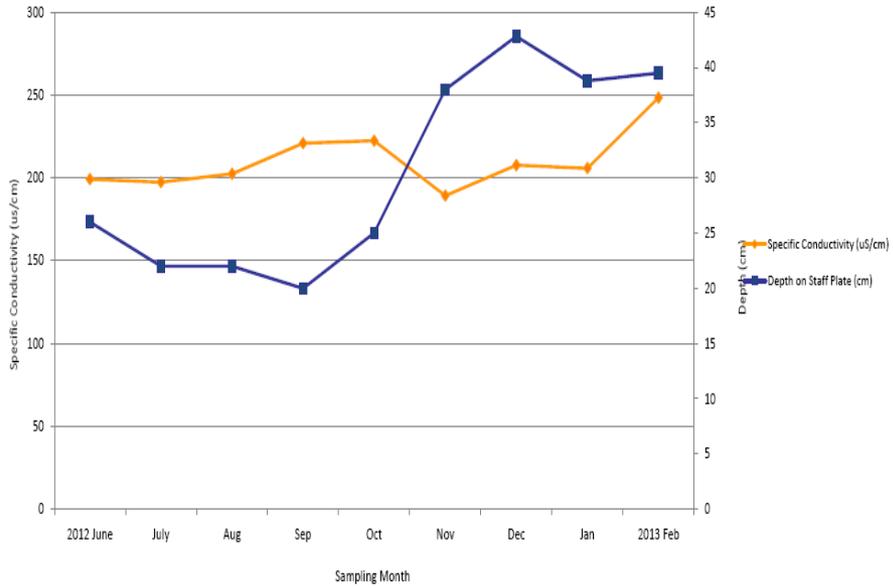
Specific Conductivity in Treatment Mixed from June 2012-February 2013 Plotted with Depth on a Staff Plate

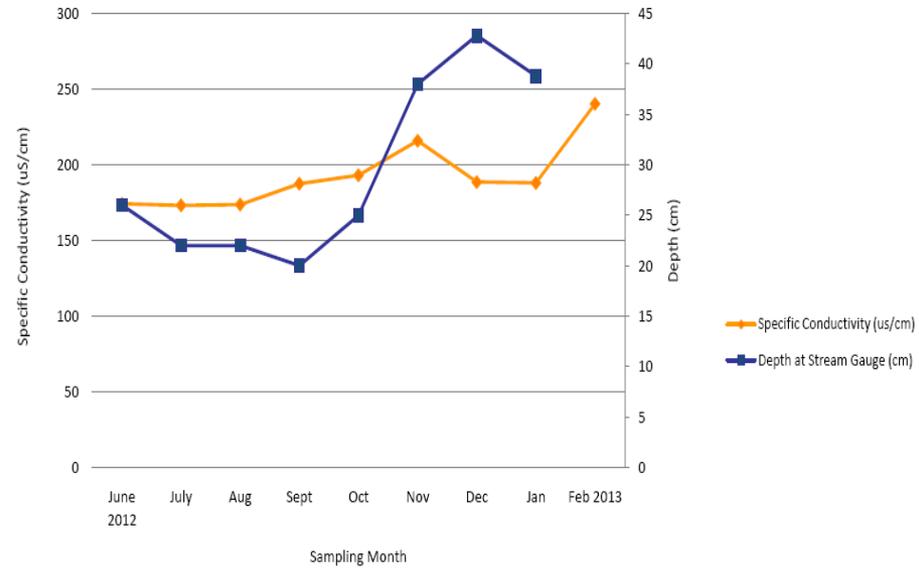
Specific Conductivity for Treatment Raw from June 2012-February 2013 Plotted with Depth at Staff Gauge at T1

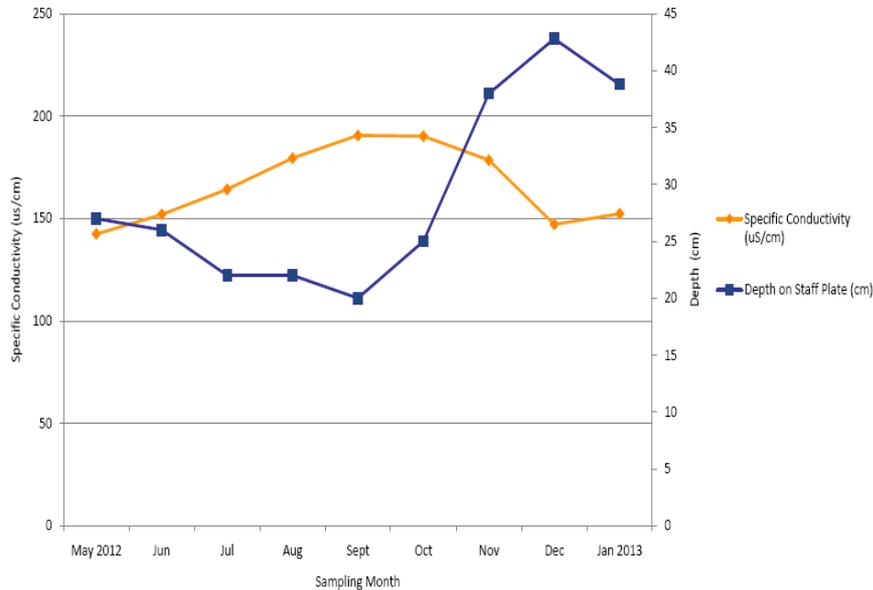
Specific Conductivity in Frostburg Reservoir from May 2012-January 2013 Plotted with Depth at Staff Gauge

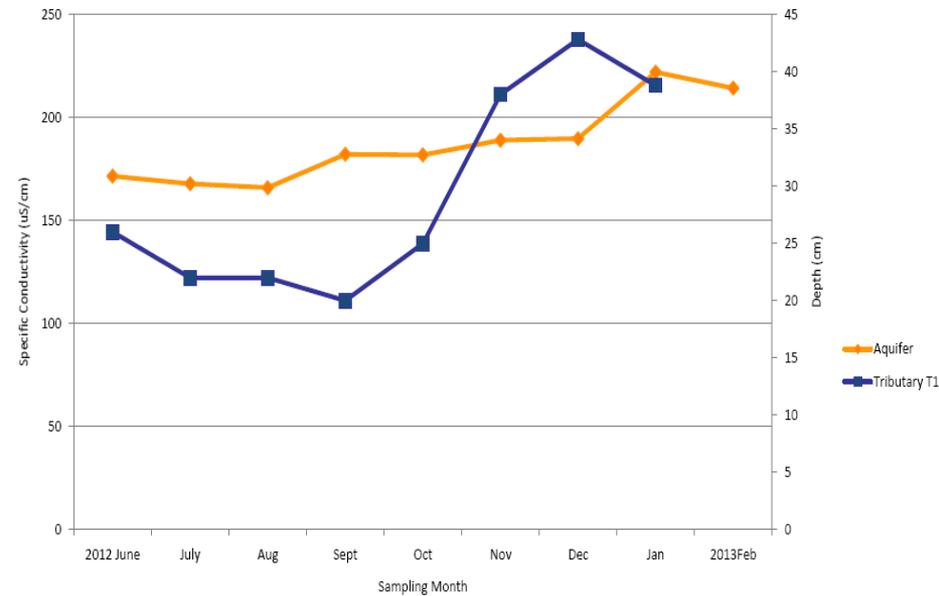
Specific Conductivity in Aquifer from June 2012-February 2013 Plotted with Depth on a Staff Plate

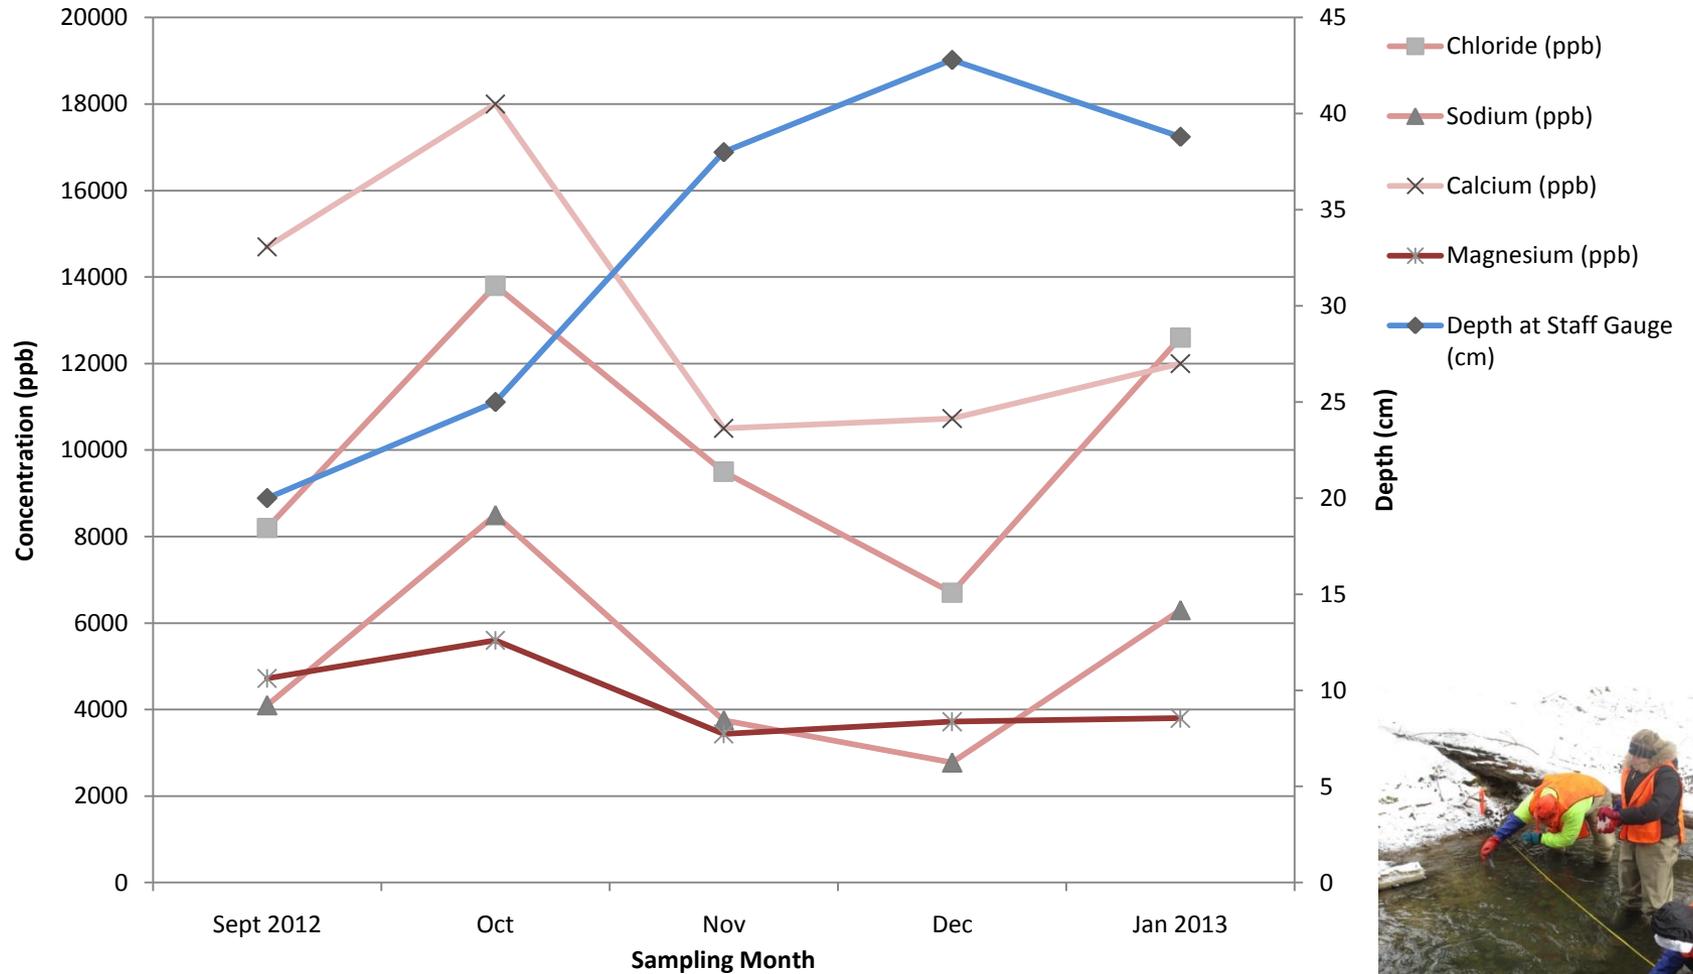
Chloride, Sodium, Calcium, & Magnesium Levels in Tributary T1 September 2012-February 2013 Plotted with Depth at the Staff Plate

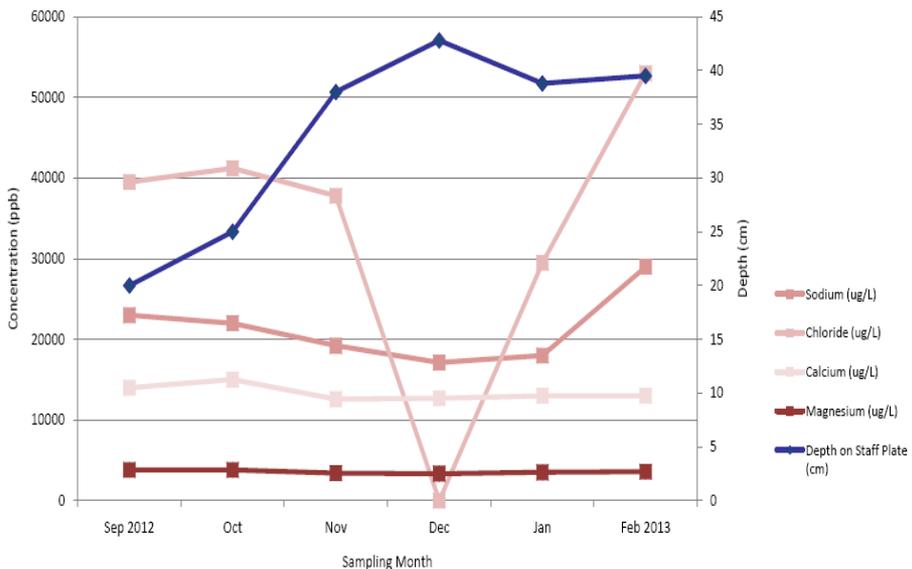
Chloride, Sodium, Calcium & Magnesium Levels in Treatment Mixed
September 2012-February 2013 Plotted with Depth at Staff Plate

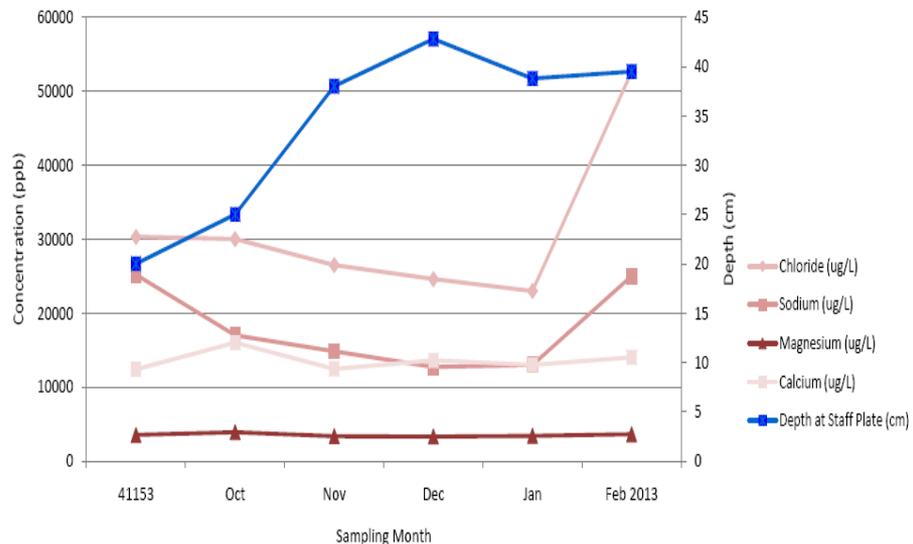
Chloride, Sodium, Calcium and Magnesium at Treatment Raw
September 2012-February 2013 Plotted With Depth At Stream Plate

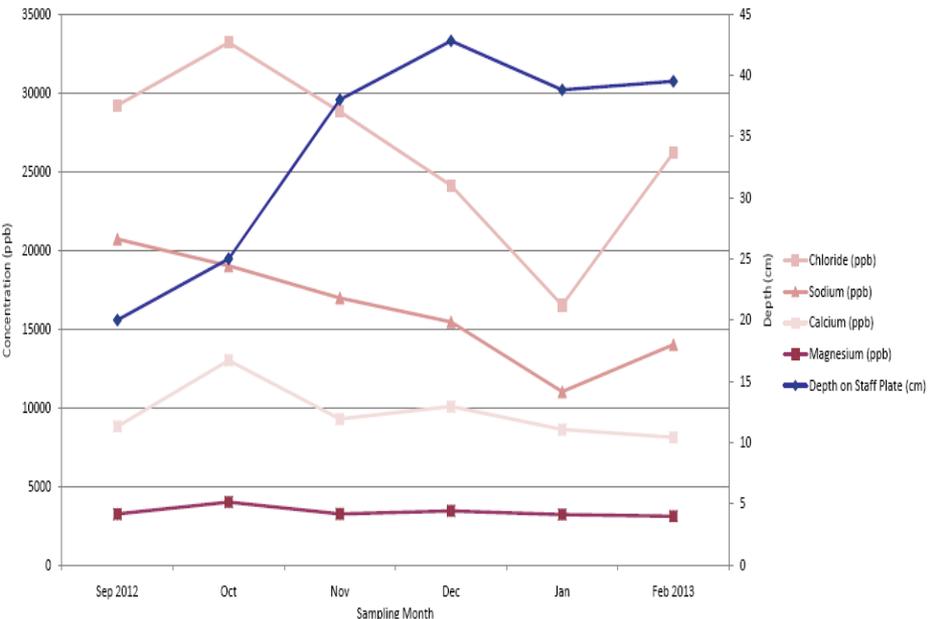
Chloride, Sodium, Calcium, & Magnesium at the Frostburg Reservoir from September
2012-February 2013 Plotted with Depth at the Staff Gauge

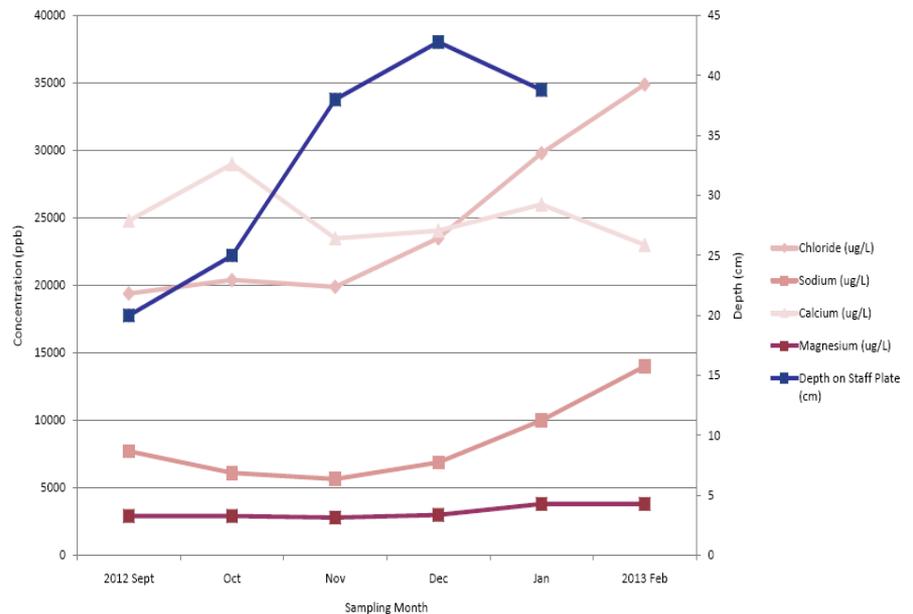
Chloride, Sodium, Calcium & Magnesium Levels in Aquifer
September 2012-February 2013 Plotted with Depth at Staff Plate

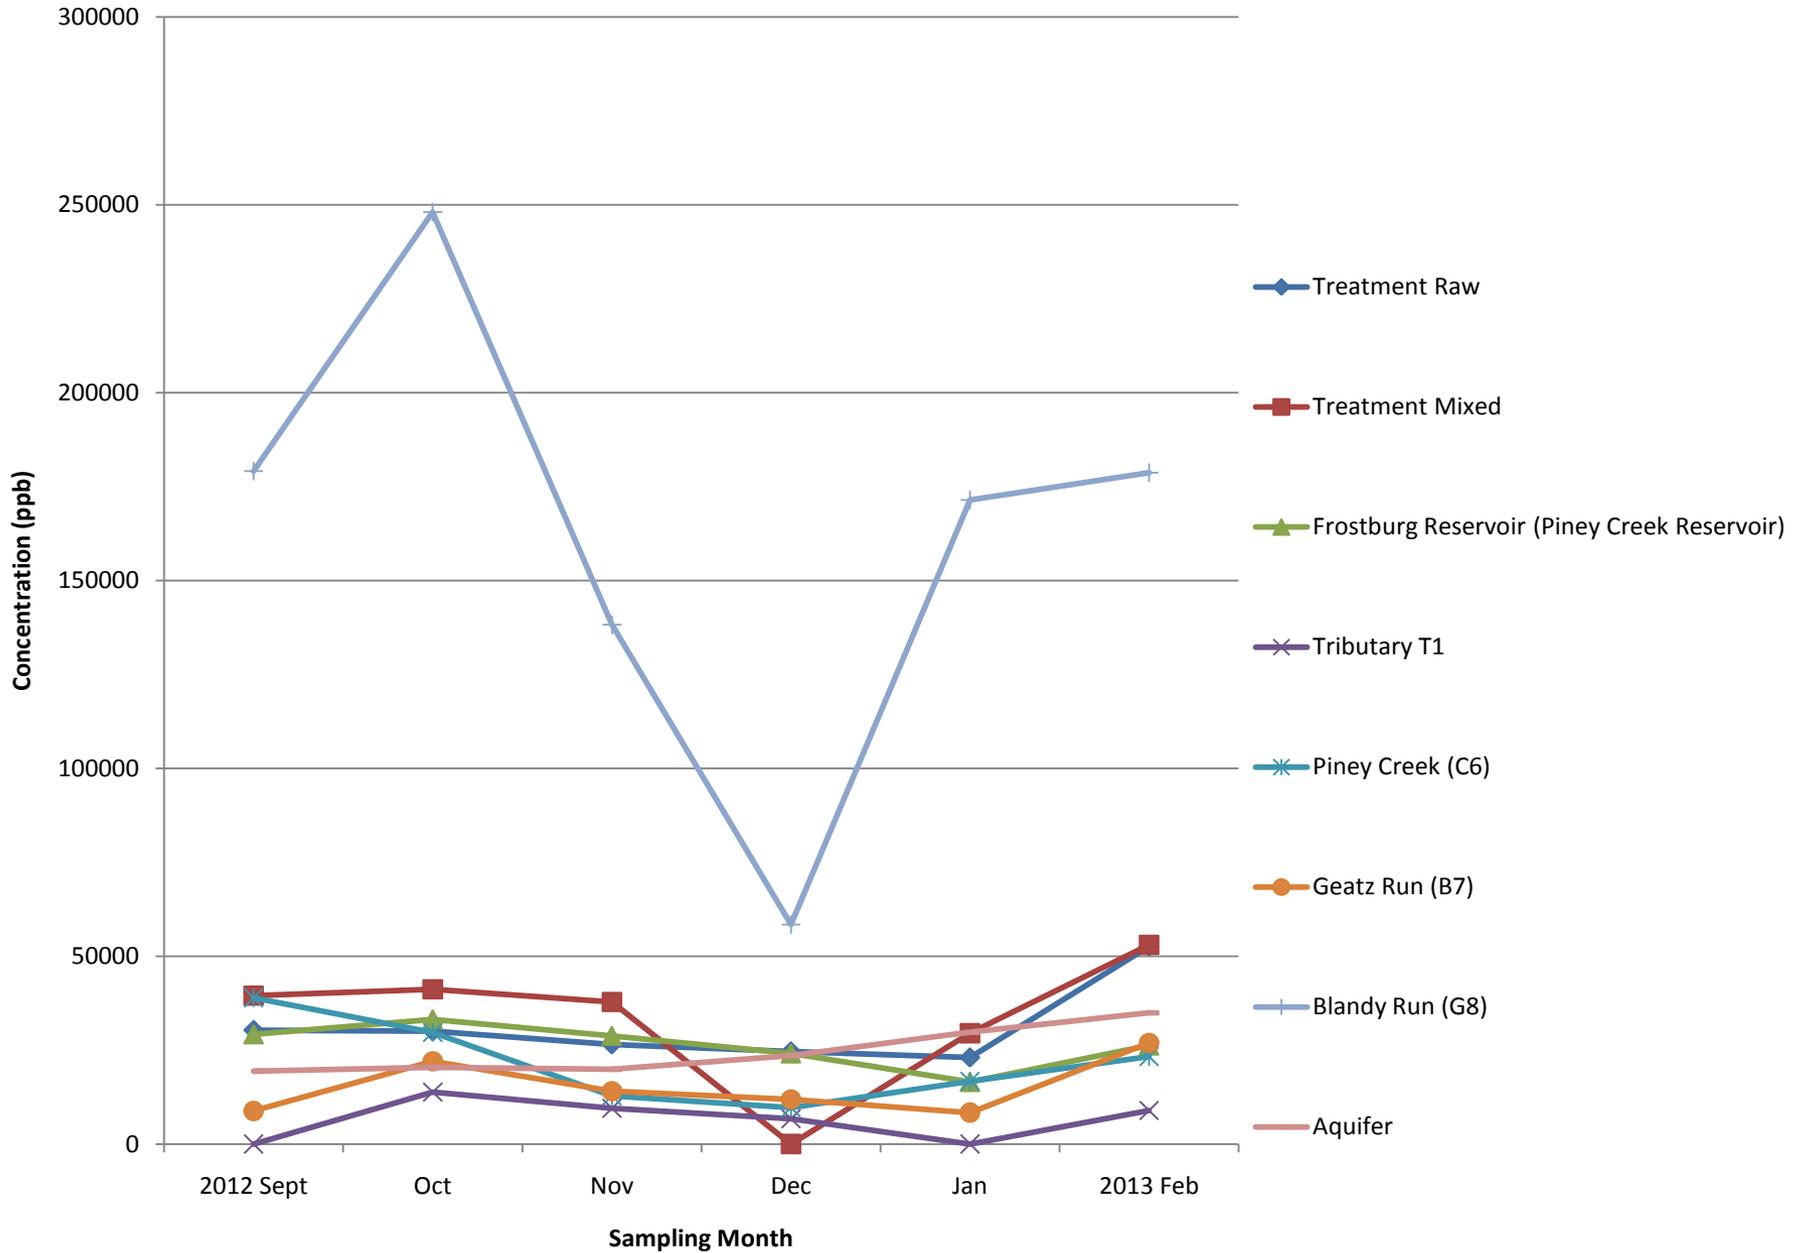
Chloride Concentrations at all 8 testing sites Sept 2012-Feb 2013

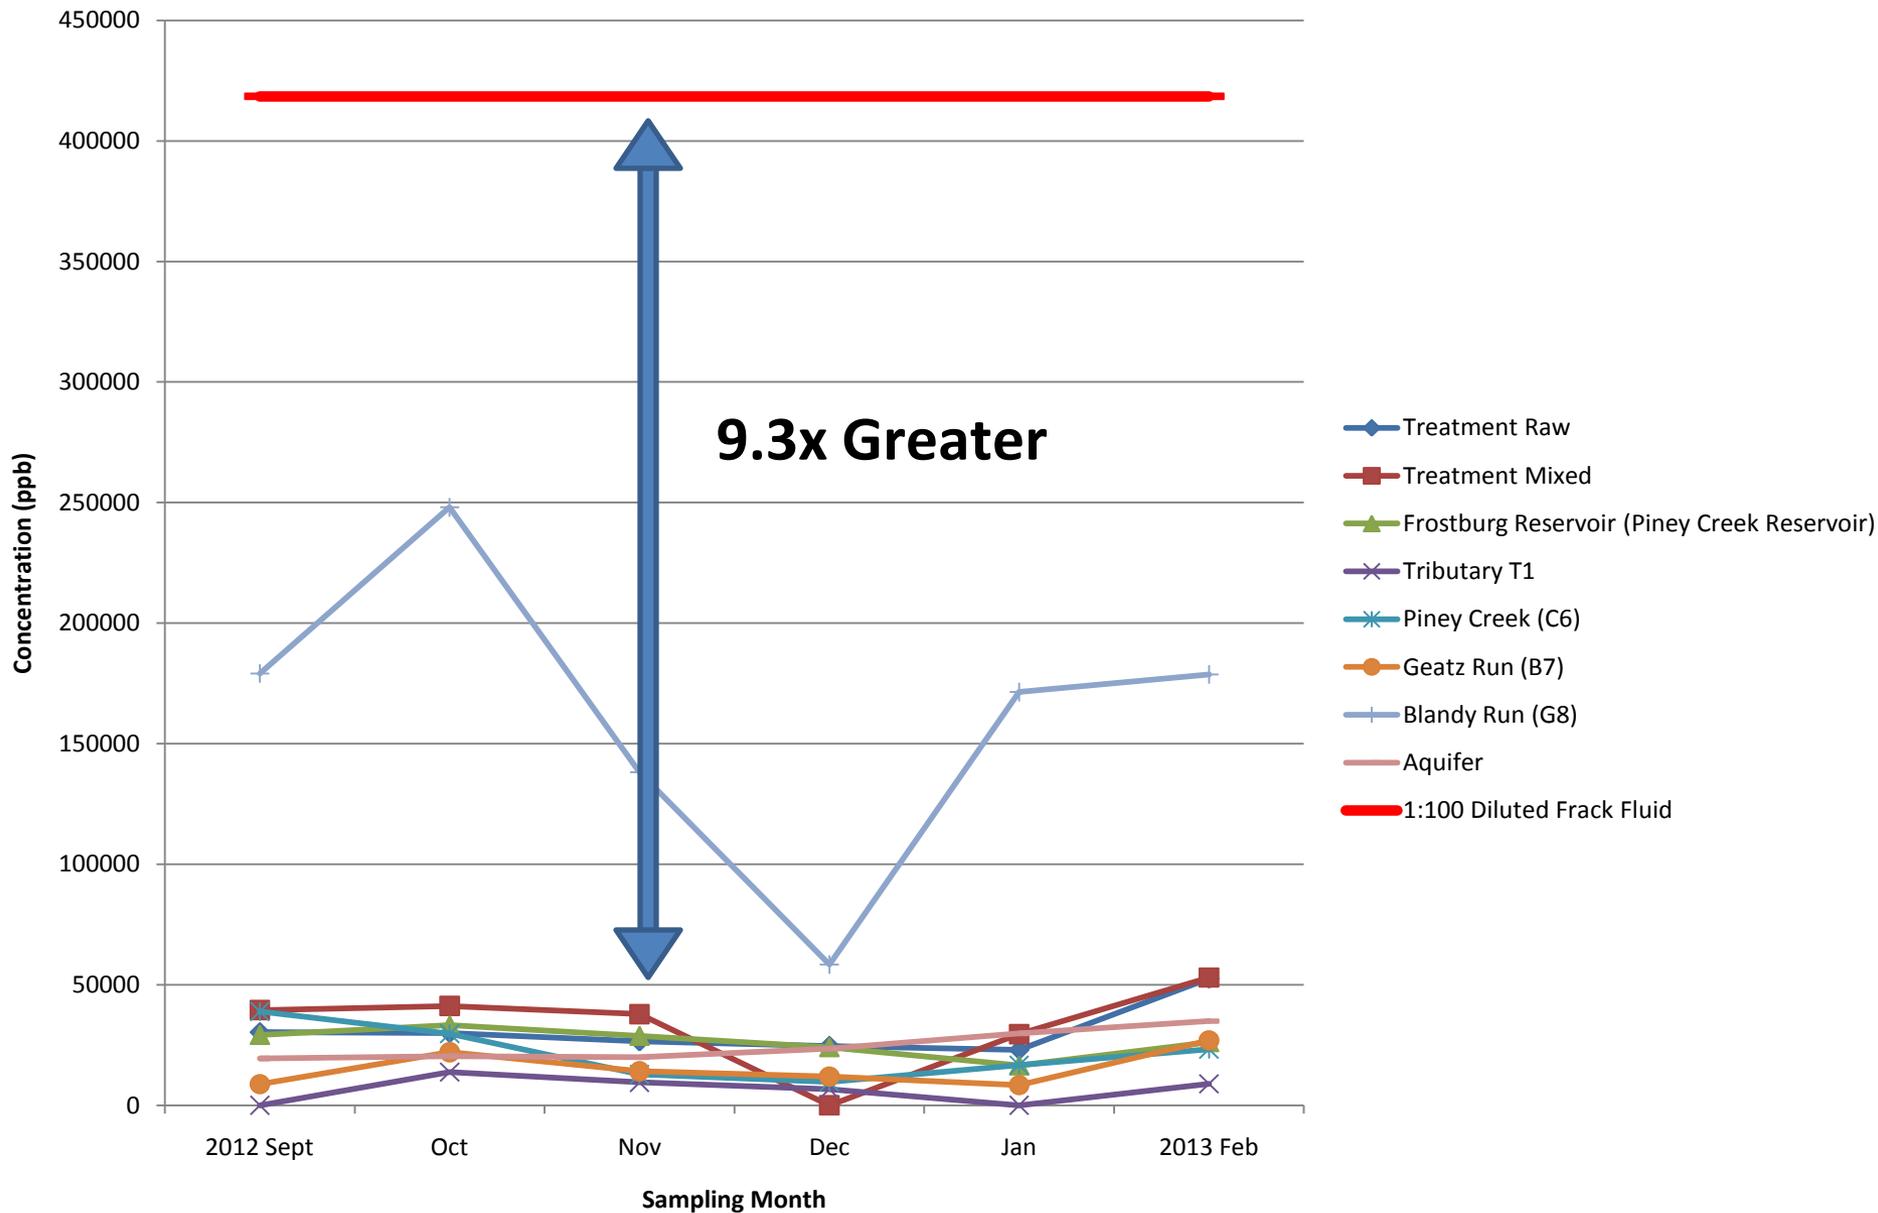
Chloride Concentrations at all 8 testing sites Sept 2012-Feb 2013

1:100 Diluted Frack Fluid also shown

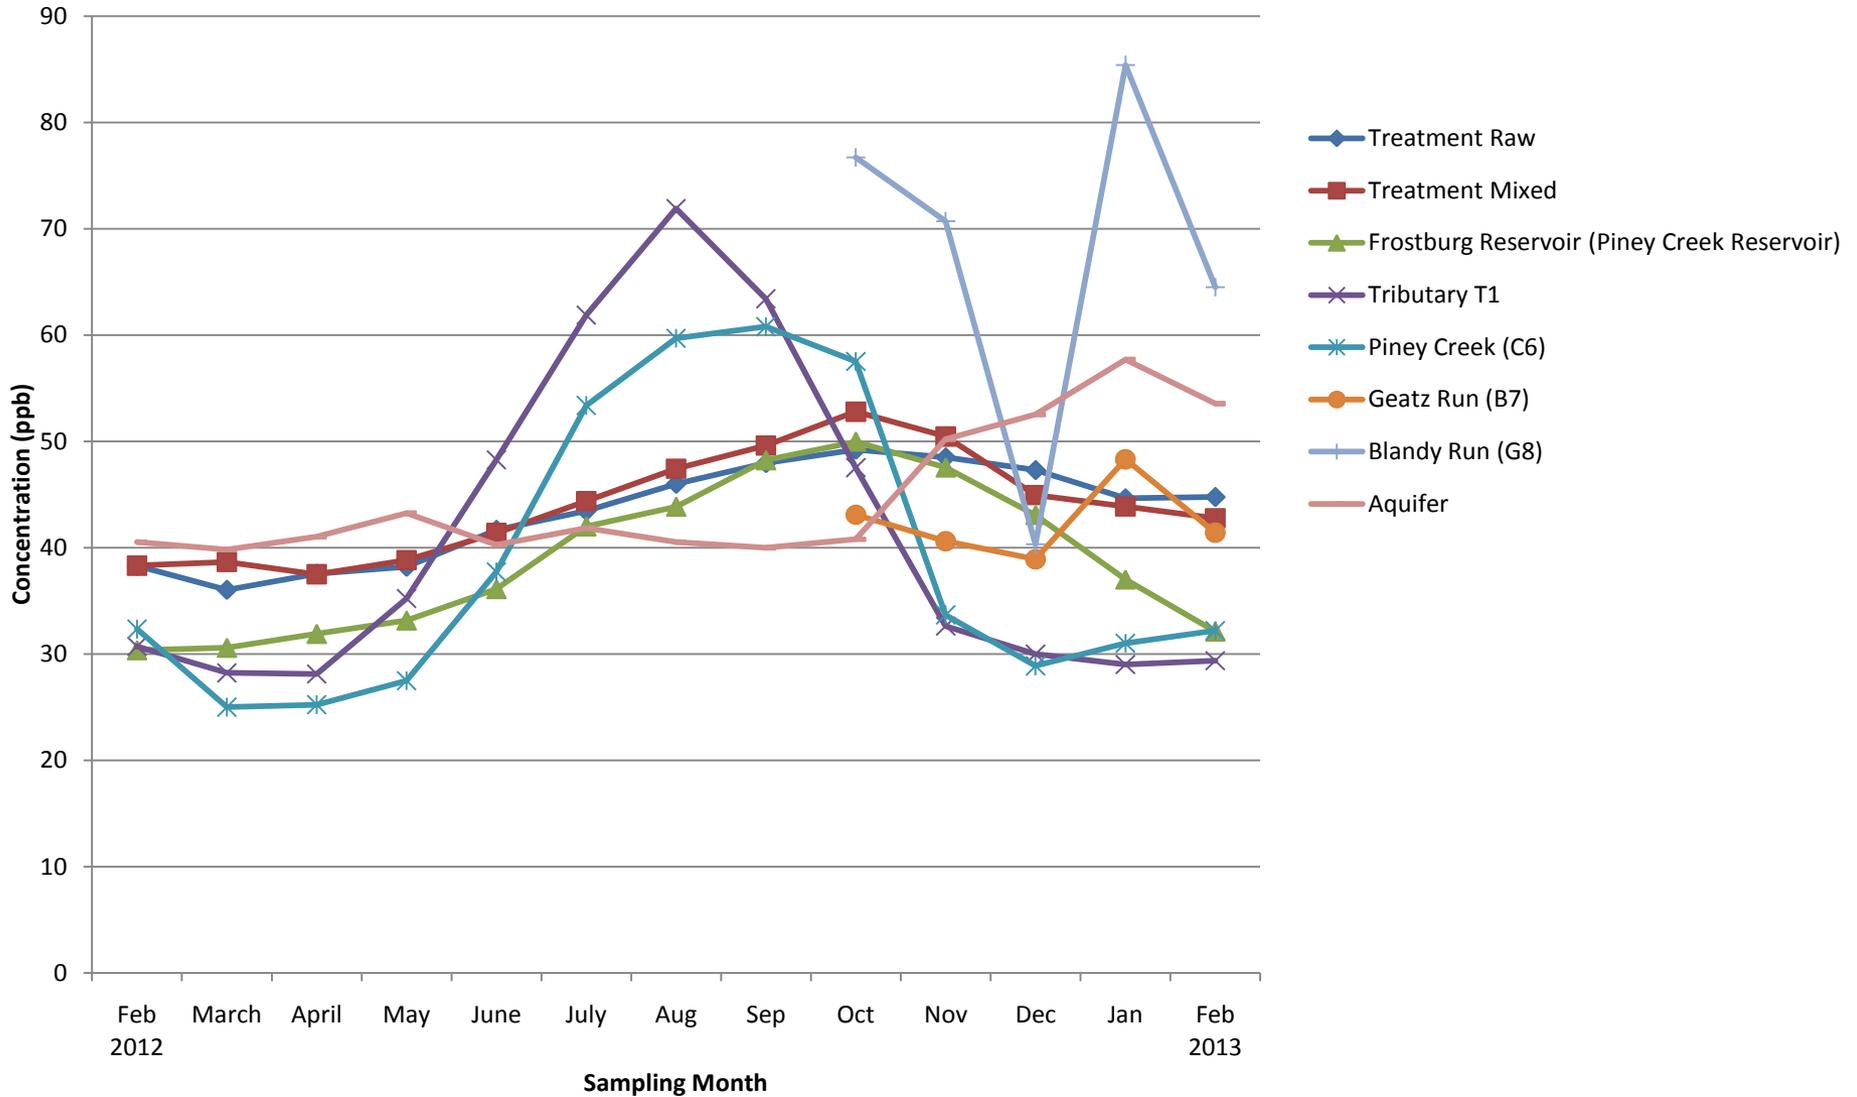
Strontium Concentrations at all 8 Testing Sites Feb 2012-Feb 2013

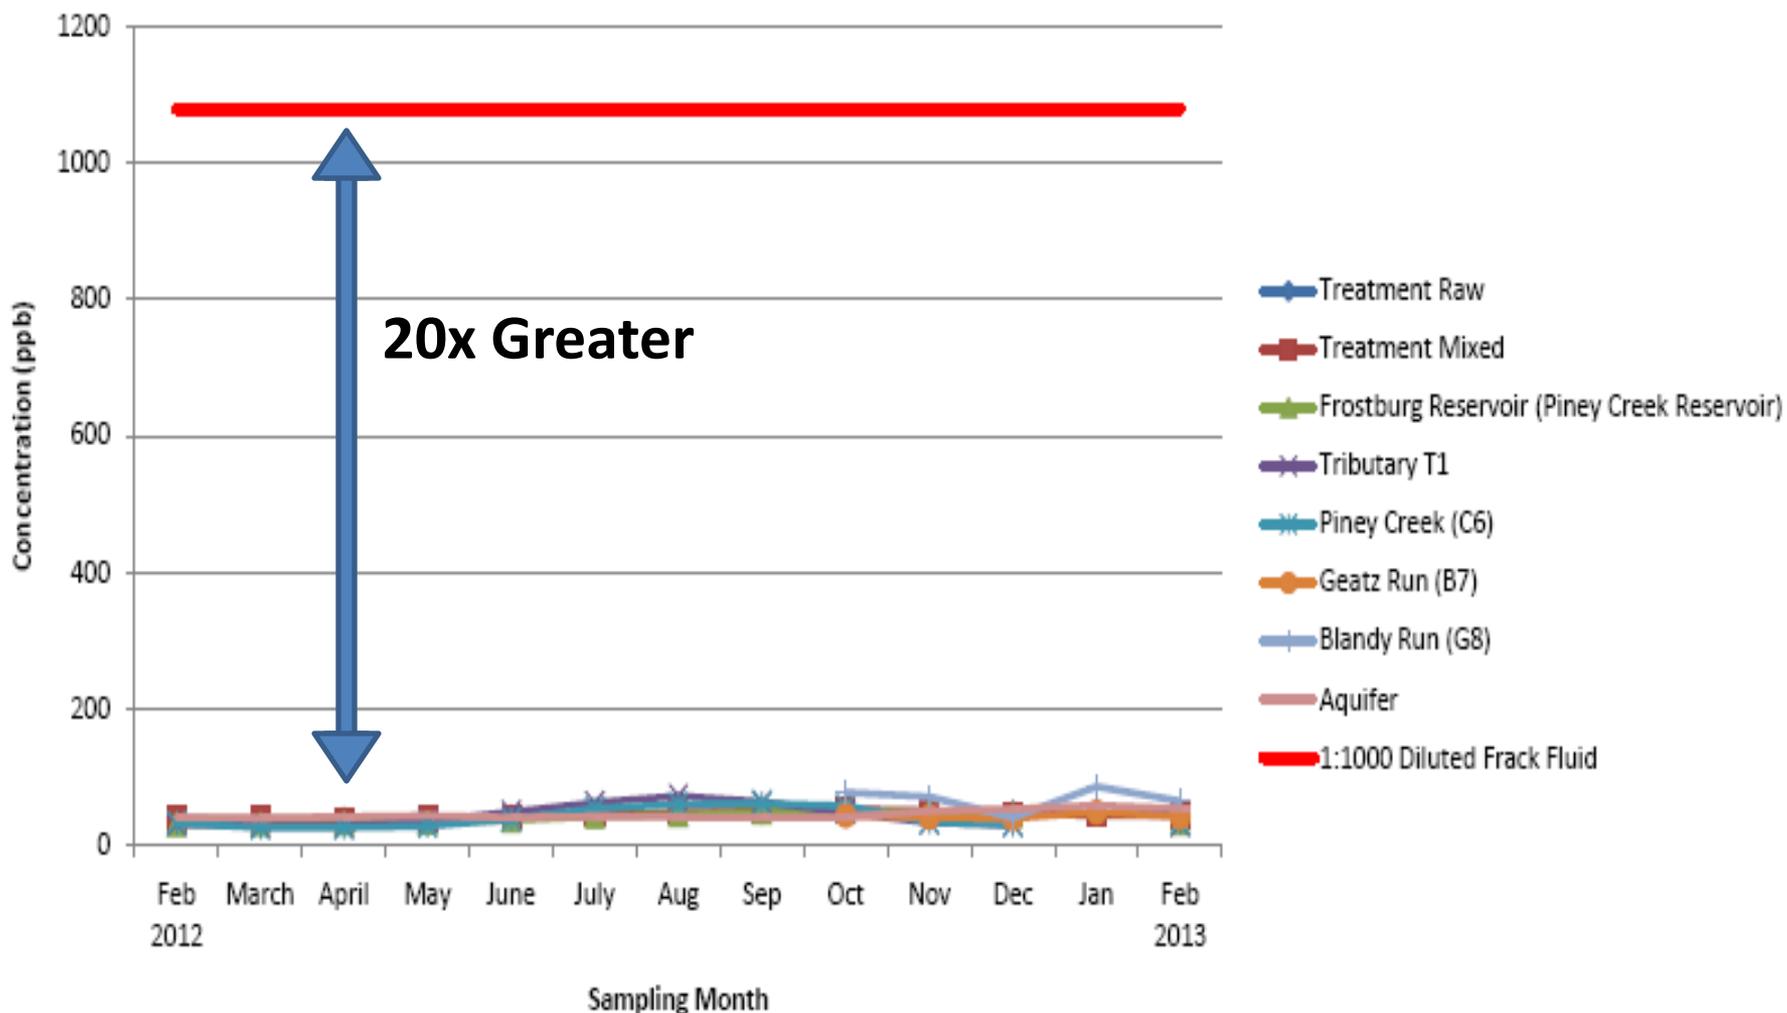
Strontium Concentrations at all 8 Testing Sites Sept 2012-Feb 2013 with 1:1000 Diluted Frack Fluid
