Fracking: Pros, Cons, Uncertainty, and Protecting the Safety of Frostburg's

Drinking Water

Mountain Ridge

Environmental Science Students

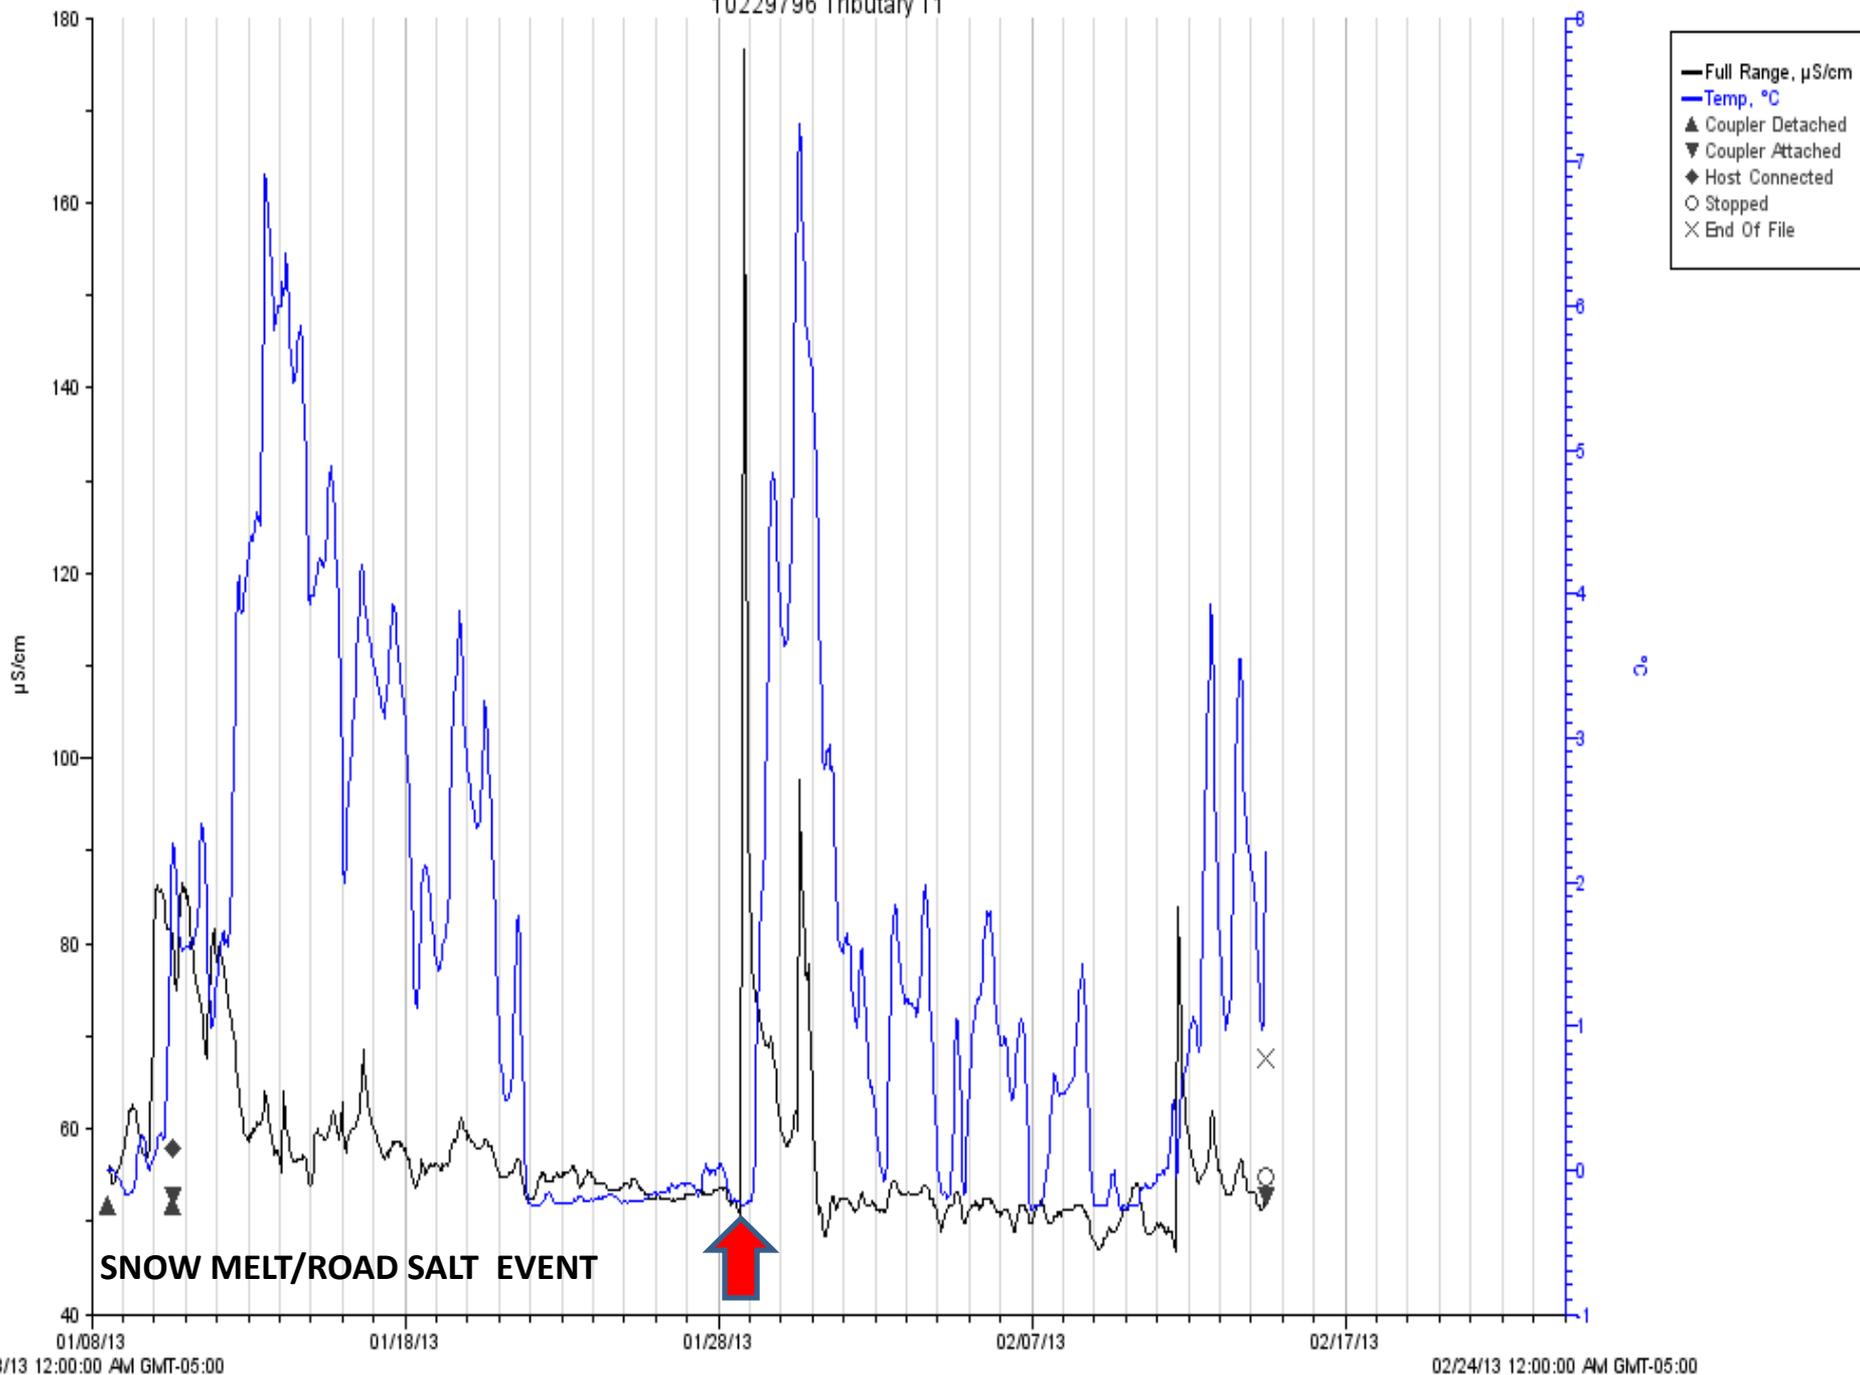
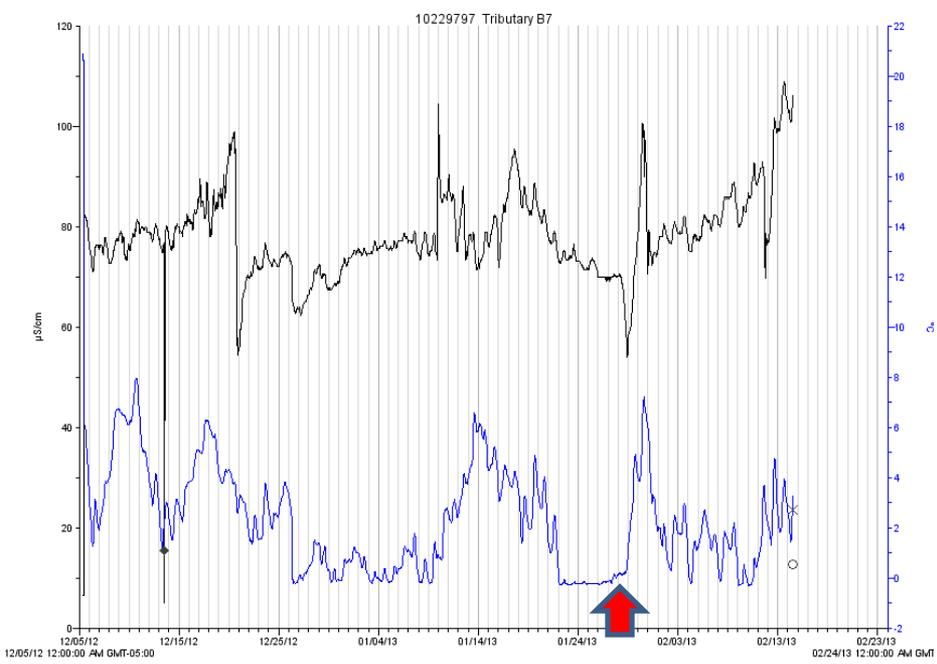
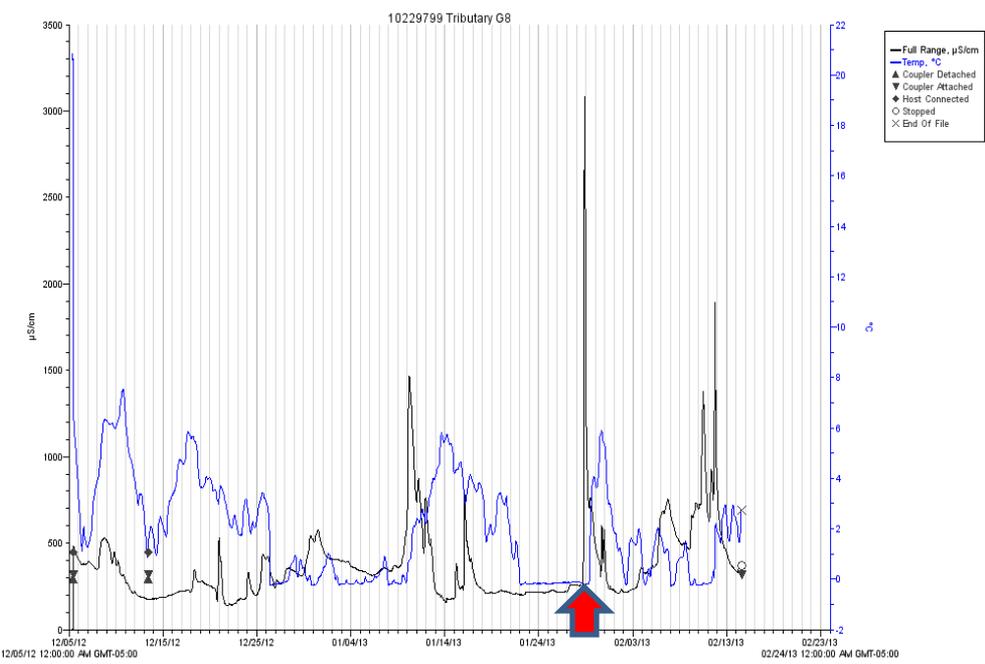
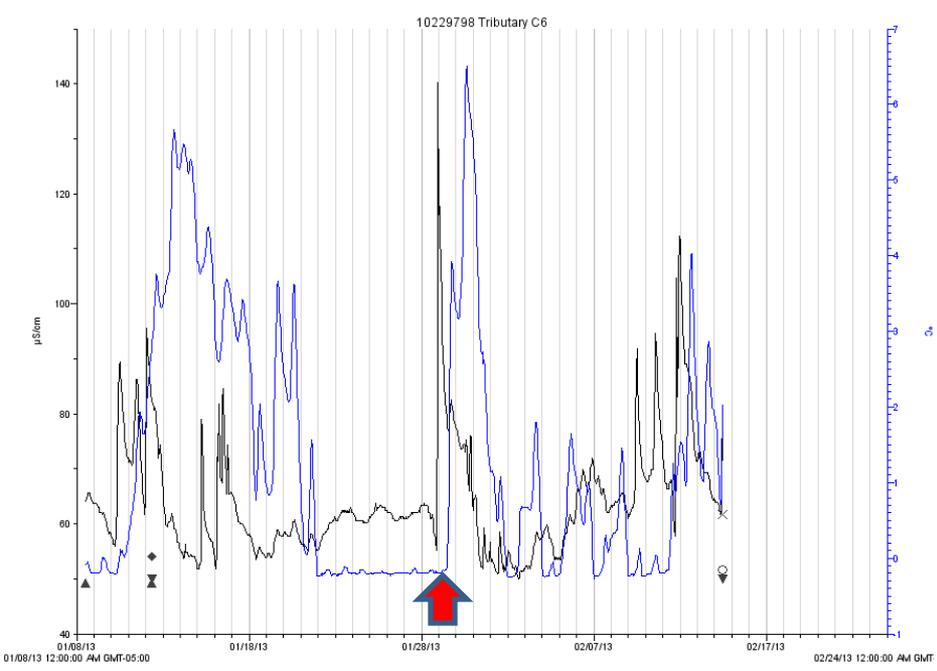
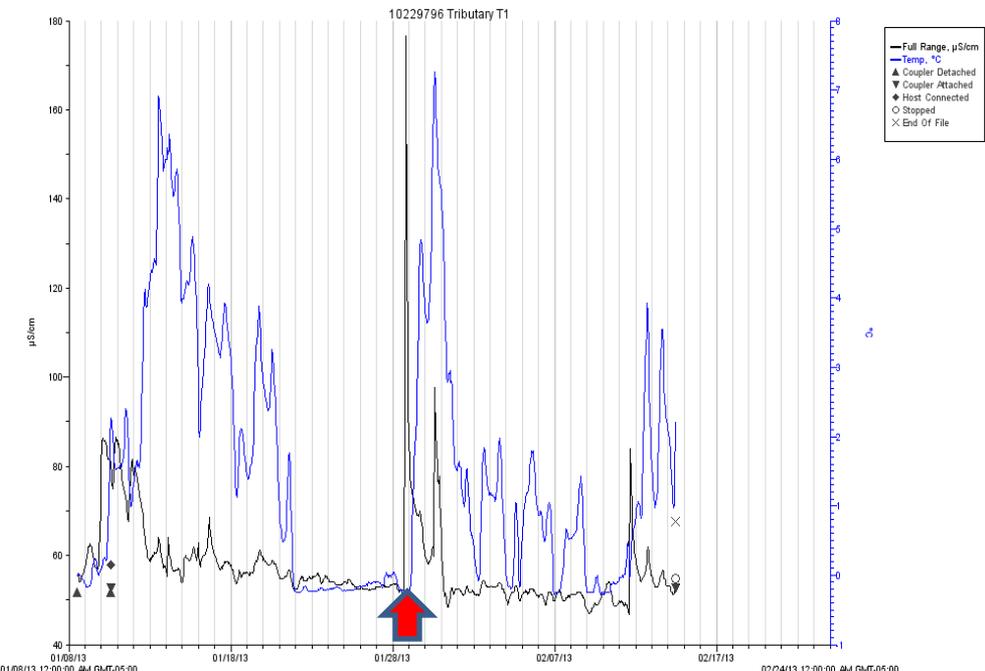
10229796 Tributary T1

- Full Range, $\mu\text{S/cm}$
- Temp, $^{\circ}\text{C}$
- ▲ Coupler Detached
- ▼ Coupler Attached
- ◆ Host Connected
- Stopped
- × End Of File

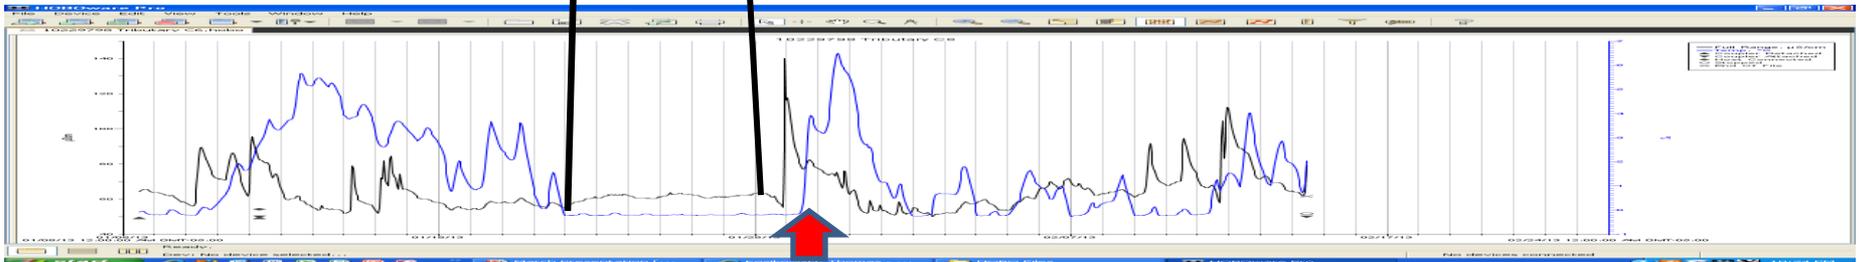
**What might a contamination event look like if frack fluid is diluted 1:1000?
(peak is 700 us/cm)(made to scale)**

Pure Frack Fluid = 700,000 us/cm
